## Structure Tech Home Inspections

# Inspection Report

**Property Address:**  
12345 Happy Lane  
Minneapolis MN

<b>Date:</b> 8/15/2017	<b>Time:</b> 08:30 AM	<b>Report ID:</b>
<b>Property:</b> 12345 Happy Lane Minneapolis MN	<b>Customer:</b> Experienced Home Buyer	<b>Real Estate Professional:</b>

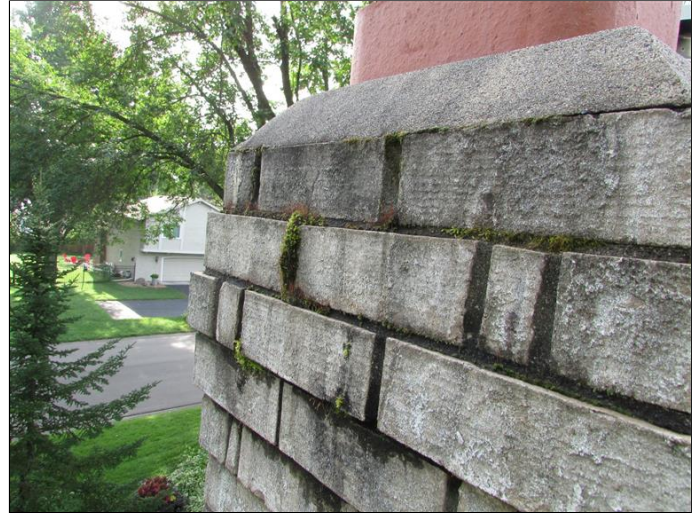
There were cracks in the chimney walls that will allow water into the chimney, leading to deterioration and possibly interior leaks. Have the chimney serviced / repaired by a [CSIA Certified Chimney Sweep](#).

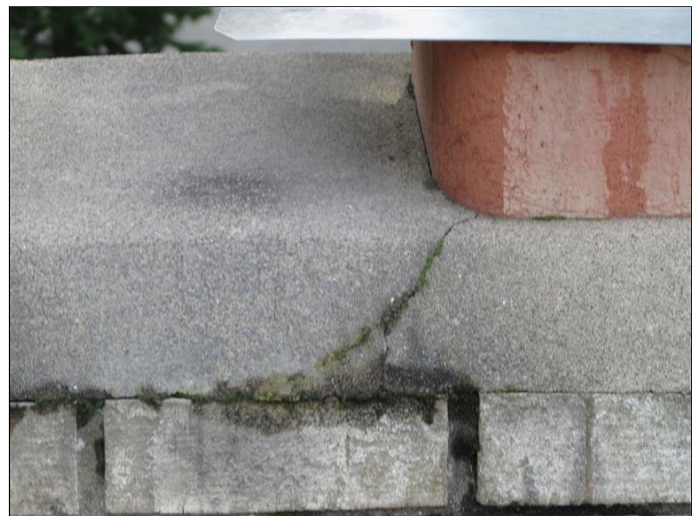
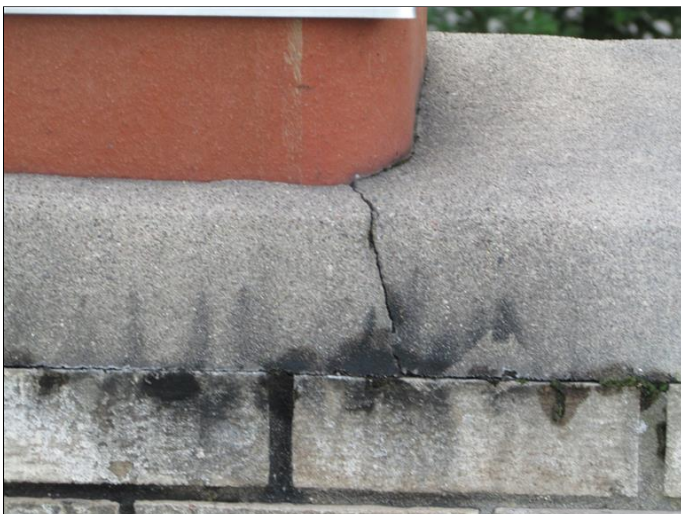
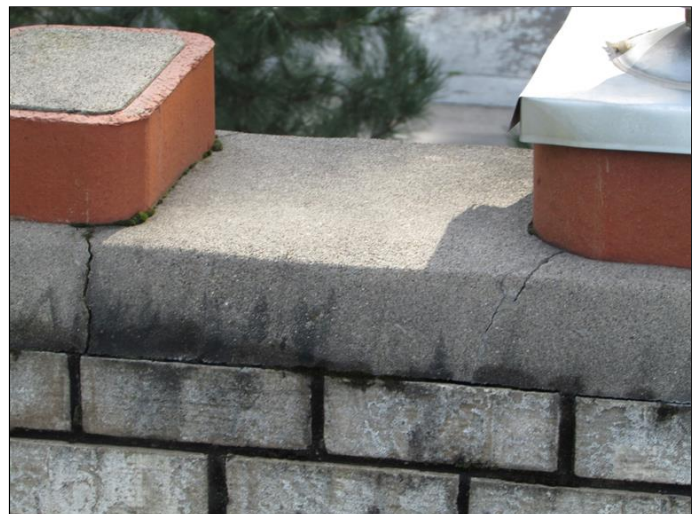
The chimney crown was cracked. These cracks will allow water into the chimney and should be sealed to help prevent damage to the chimney.

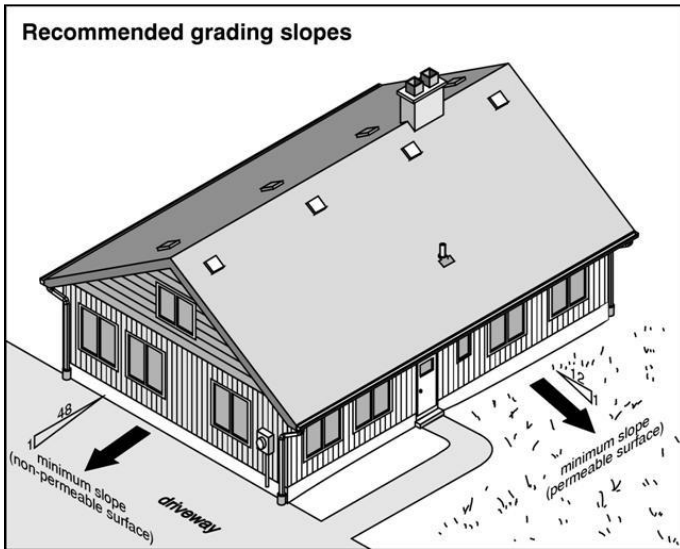
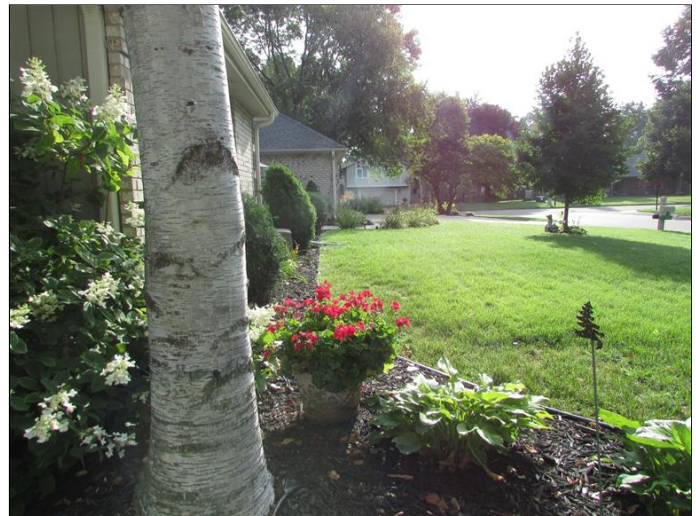
- i The ground was flat next to the building at the front yard, which could allow for water to enter the basement or cause excessive soil pressures against the foundation walls. The soil or the hard surfaces should slope away from the house for at least ten feet if possible, to help prevent basement water intrusion and foundation problems.

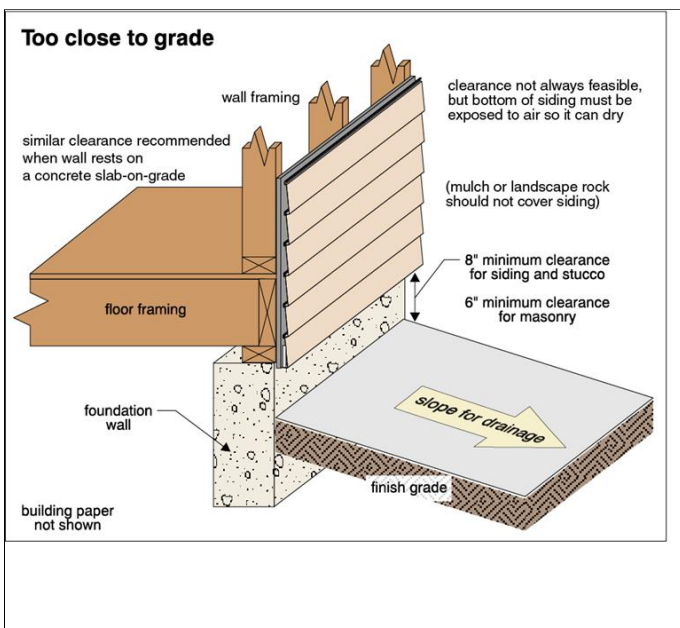
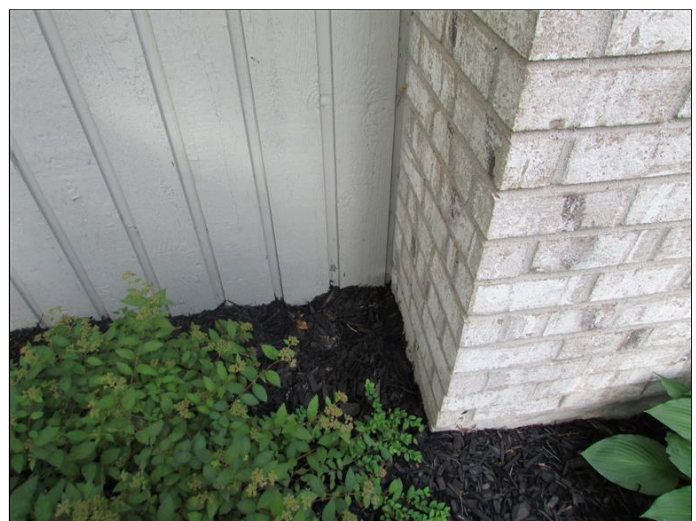
- i The siding was too close to the ground, and water could wick up into the walls and cause damage. The siding should be kept at least six inches above the surround grade. There were no signs of rotting, but the siding should be monitored where it's too close to the ground.

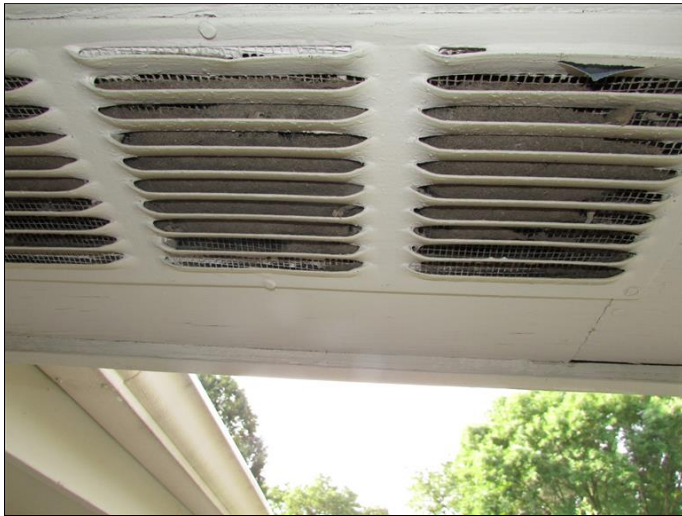
🕒 The soffit vents were dirty and can restrict airflow into the attic. Airflow helps preserve the life of the roof, and may help prevent ice dams. Clean or replace the vent covers.

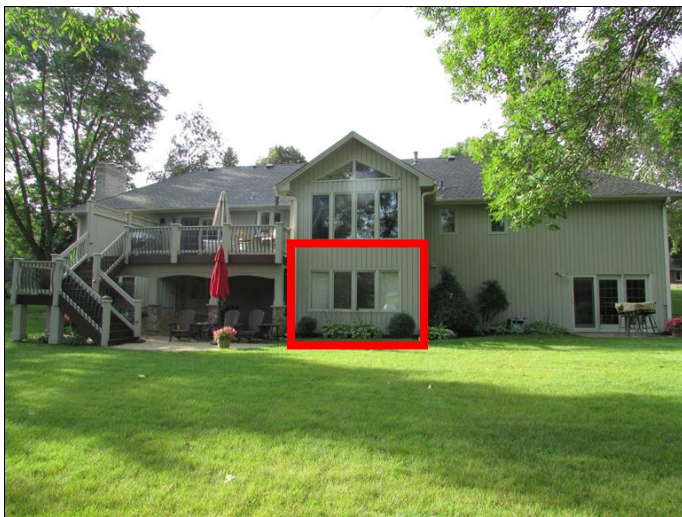
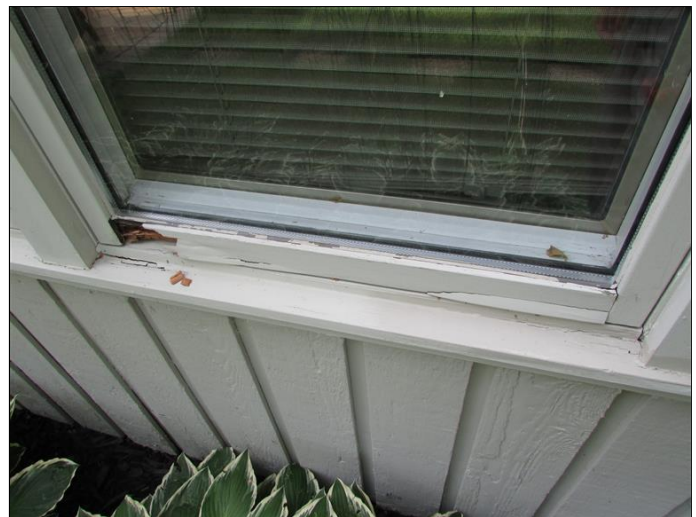
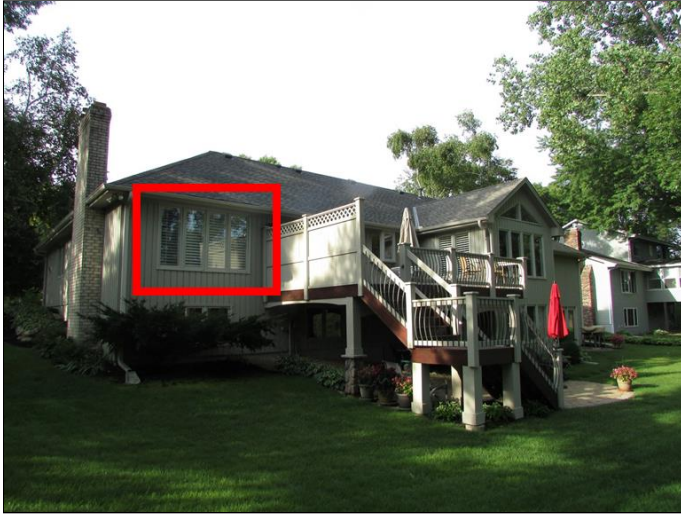
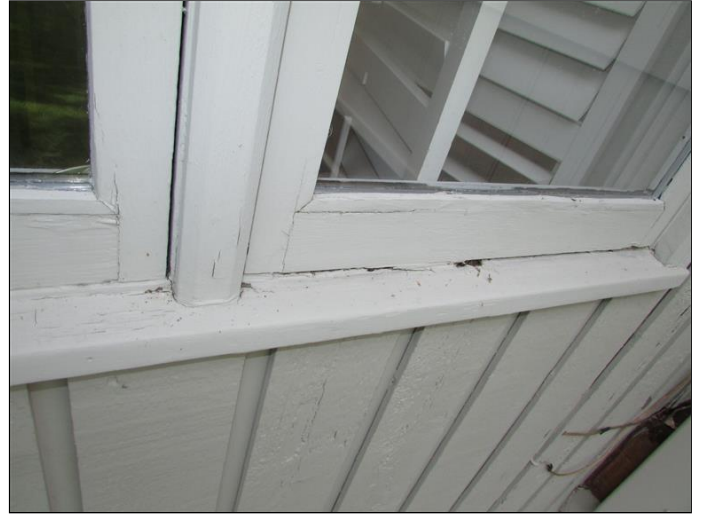
❌ (1) The windows at the back of the house indicated in the photos below were rotted and should be replaced.

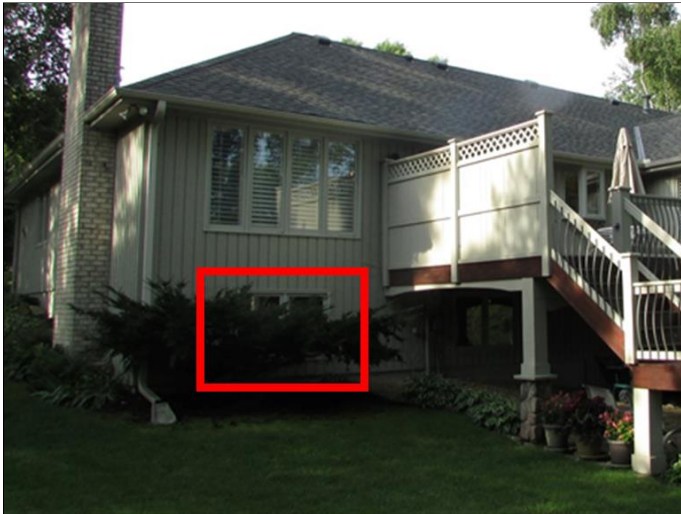
⊗ (2) The window at the back of the house indicated in the photo below was beginning to rot at the bottom corners of the mullion, and should be serviced to help forestall further deterioration.

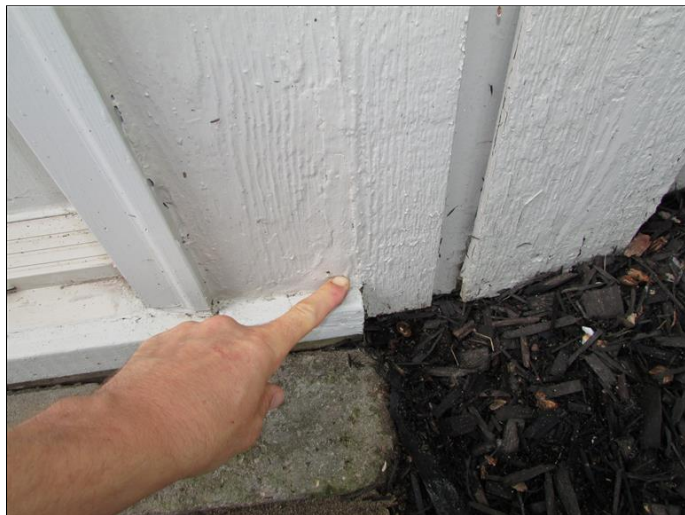
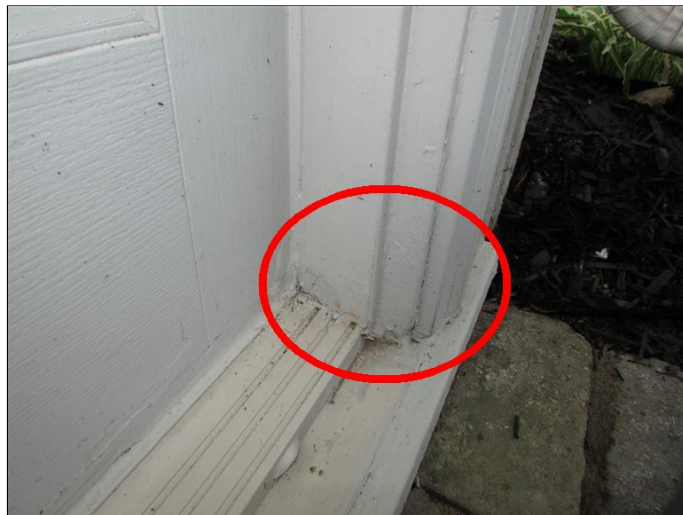
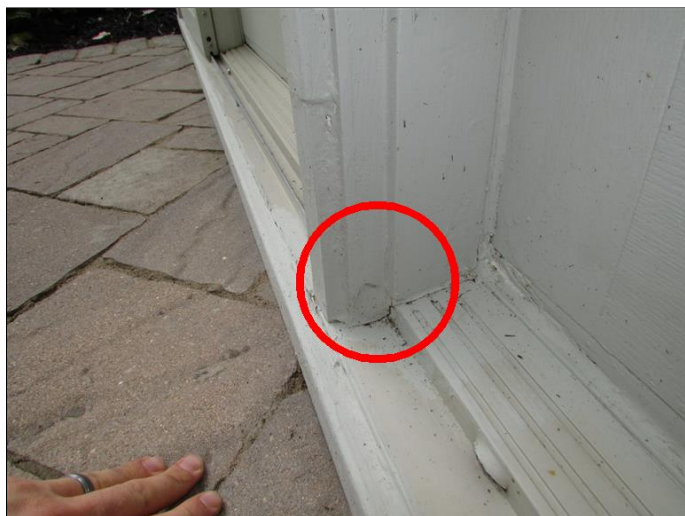
- (1) There was soft and deteriorated wood all around and at the basement patio door. This area appears to have been recently caulked and painted, but a moisture meter indicated high levels of moisture at the wood approximately 12" up. This area will likely need service again in the near future.

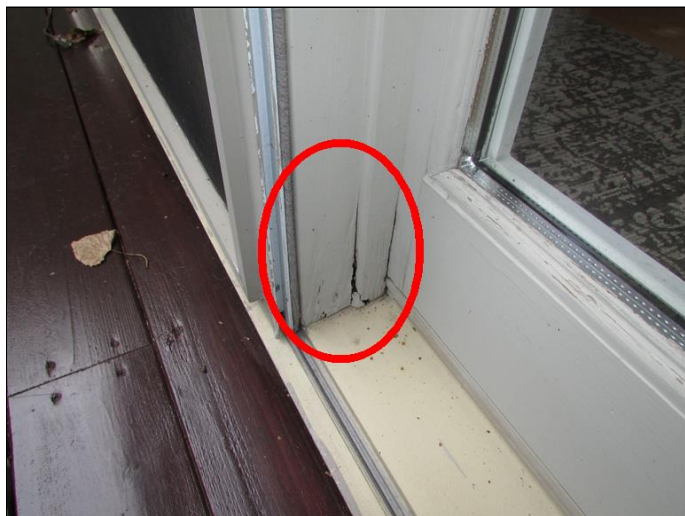
- (2) The first floor patio door was starting to rot at the bottom corner of the mullion on the west side. Have this door serviced to help forestall the rotting.

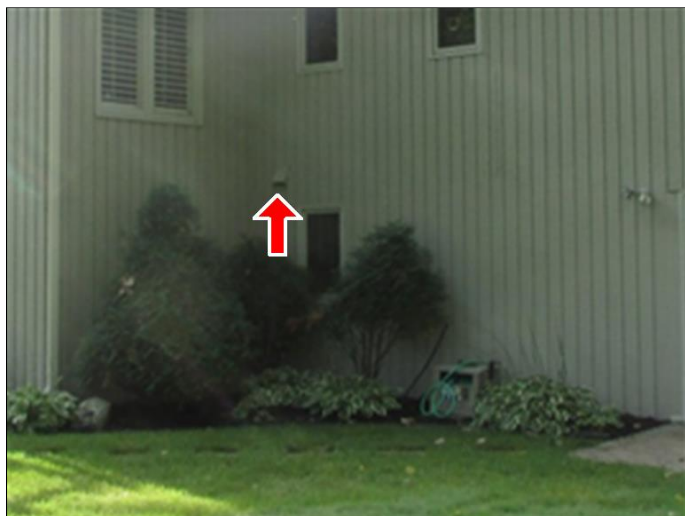
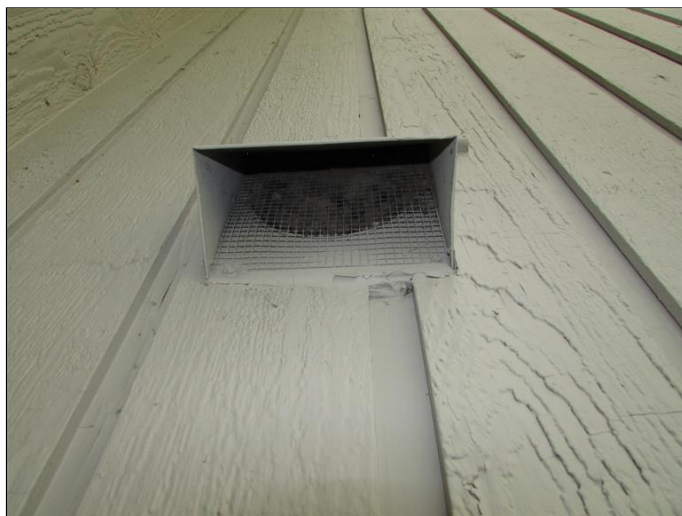
The opening that allows combustion air into the home was [dirty](#). Clean the opening and check on it frequently to make sure that sufficient combustion air is brought into the house.

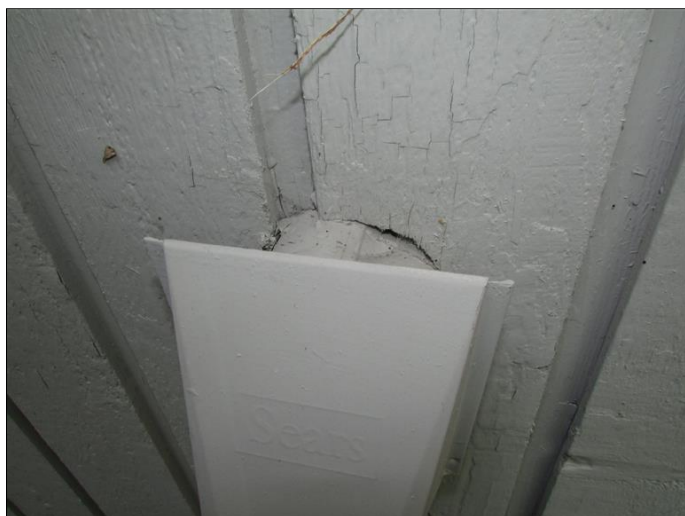
There was a gap between the dryer vent and the siding that needs to be caulked. This will help to prevent moisture intrusion, pest intrusion, and air leakage.

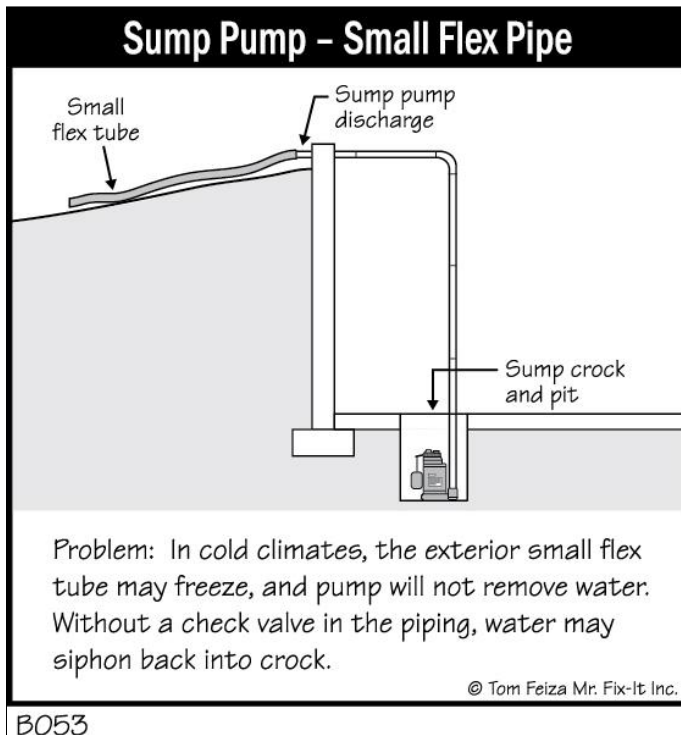
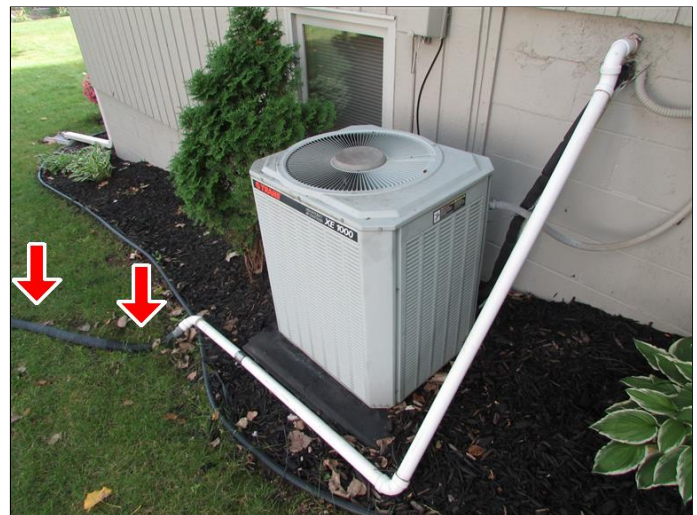
- (1) The sump pump discharge tube was directed into a corrugated tube that runs across the lawn. This has the potential to fill with ice and prevent the pump from functioning properly during the winter. Remember to disconnect the corrugated extension tubing in the fall. For more info on this topic, click here: [Potential for freezing at sump system discharge](#)

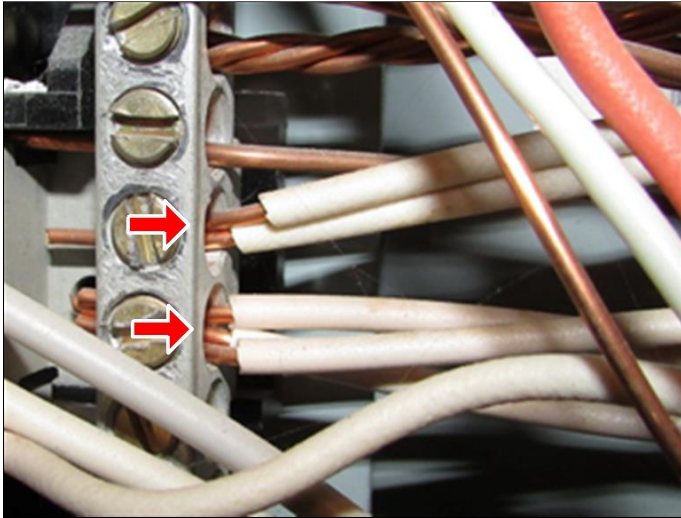
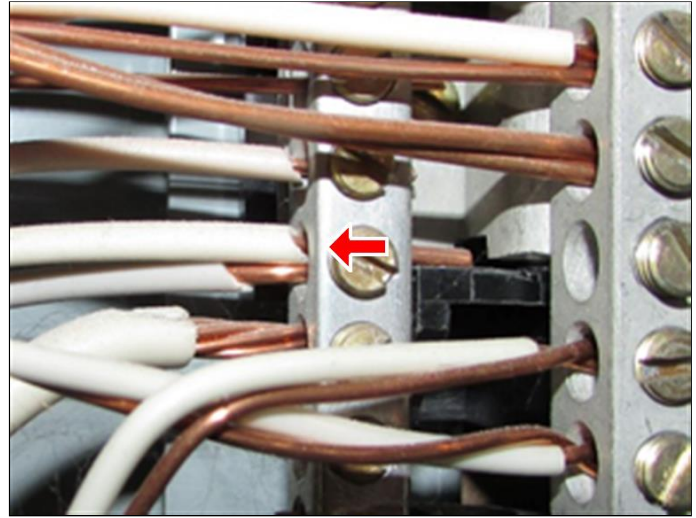
- 🔍 (1) There were several lugs on the neutral/ground bus bar that have [more than one neutral wire](#) feeding to them. Each neutral wire should be attached to a separate lug to ensure a proper physical connection and to make sure that each circuit can be worked on independently. Have this corrected.

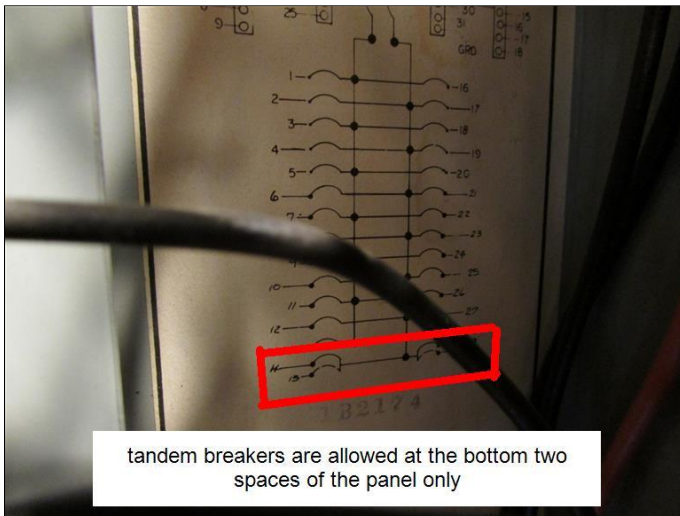
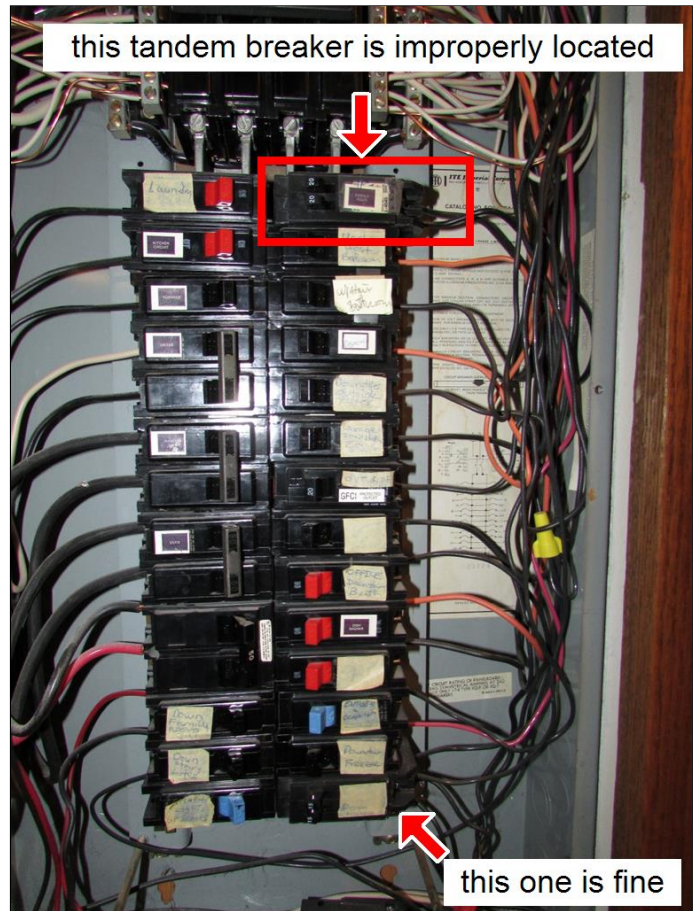
- (2) Two tandem circuit breakers were used at the panel; one was properly located, and the other wasn't. The improperly located circuit breaker might not make a proper connection at the panel, which is a potential fire hazard. Have this condition repaired by an electrician. To read more about this specific defect, click the following link: <http://structuretech1.com/2012/02/tandem-circuit-breakers/>

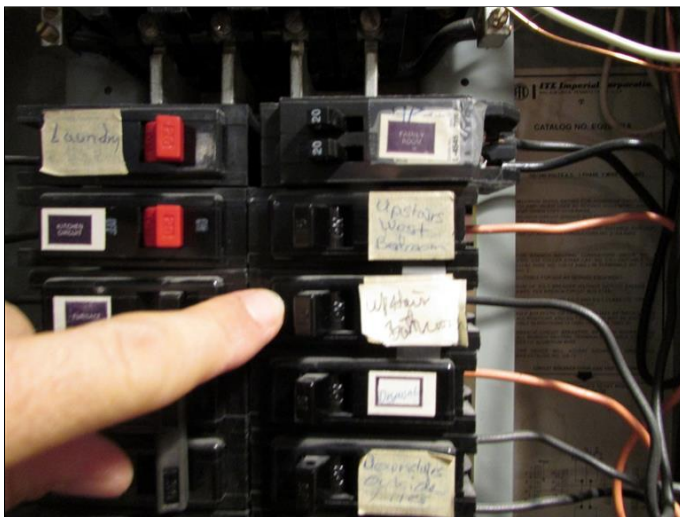
- (3) The circuit breaker at space #18, labeled "upstairs bathroom", supplied power to the upper hallway bathroom, the master bathroom, upper hallway lights, upper den (piano room) lights and outlets, and most of the recessed lights at the west basement family room. This circuit is overloaded, and it tripped several times during the inspection. Have an electrician correct the wiring. Because the main panel was filled to capacity, the fix for this condition might require the installation of a subpanel.

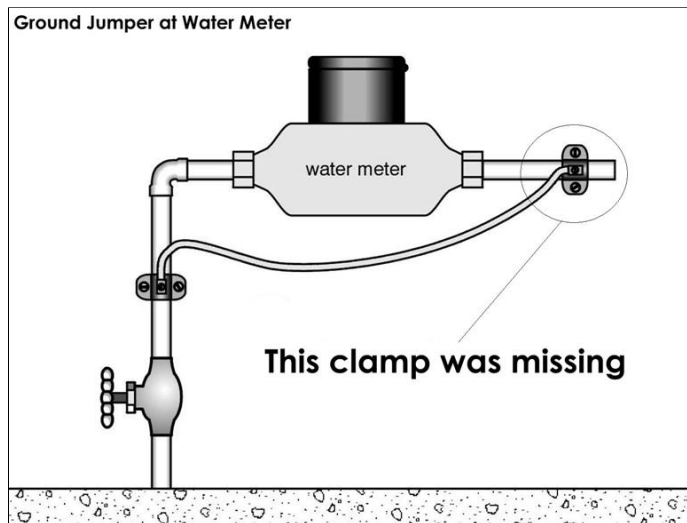
- There was no **bonding clamp** for the ground wire at the house side of the water meter. Without a bonding clamp present, the water pipes and everything metallic that they're in contact with could become energized if a 'hot' wire came in contact with them. Add a bonding clamp.

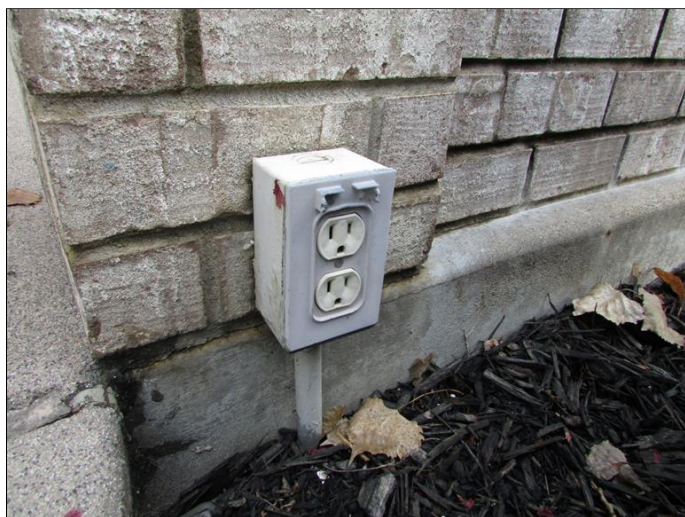
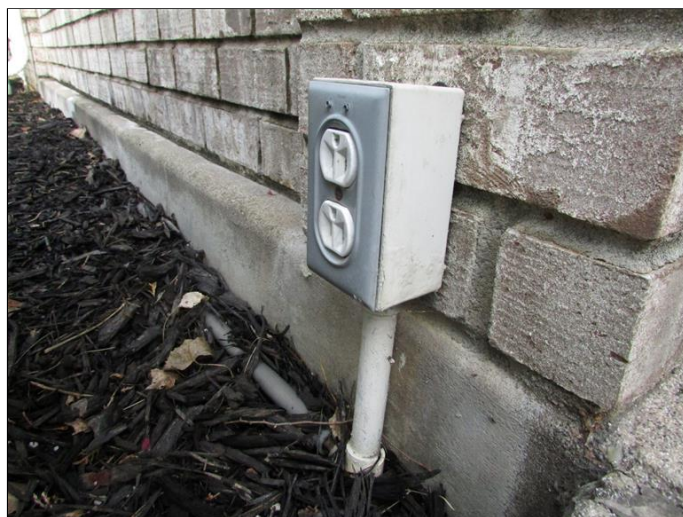
- (1) The three front outlets had missing weatherproof covers, which should be replaced to help prevent damage to the outlets. Today's standards require weatherproof covers that allow a cord to be plugged in while the cover is in the closed position.

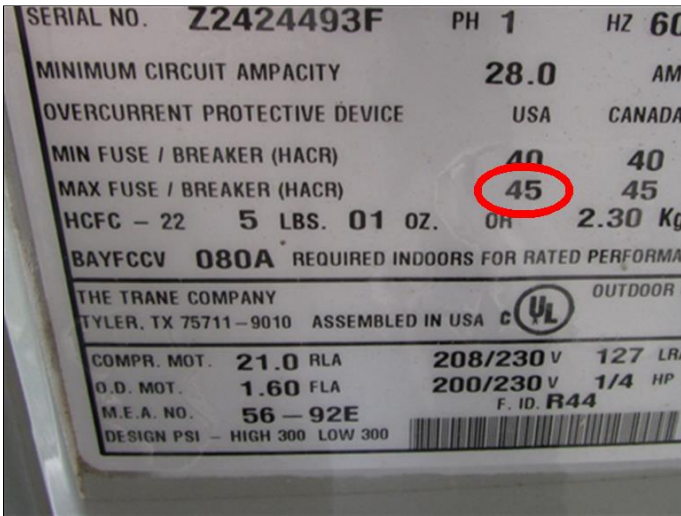
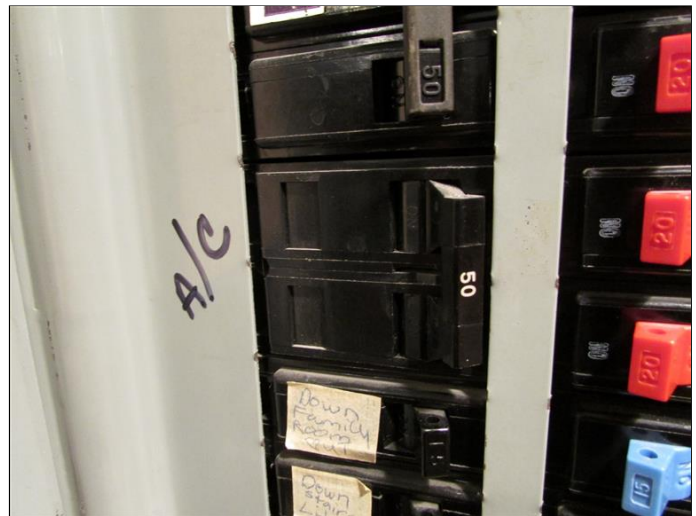
- (3) The listing for the compressor calls for a maximum fuse or circuit breaker of 45 amps, but the overcurrent protection device provided for the compressor was a 50 amp circuit breaker. Have this corrected to help prevent damage to the unit.

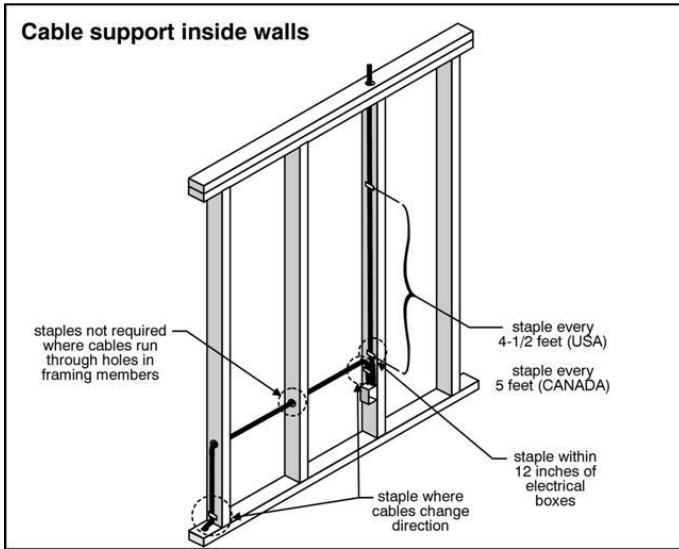
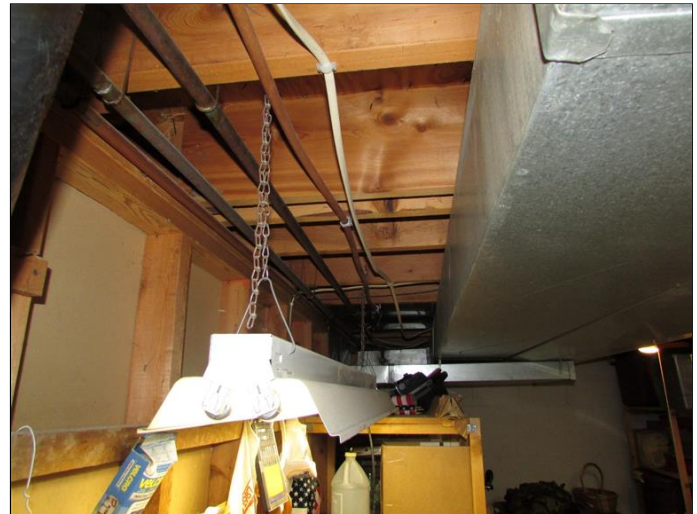
There was loose wiring in the basement. Wires should be stapled / secured within 12" of all panels, junction boxes, switches, outlets, fixtures, and every 4 1/2'. Secure the wires.

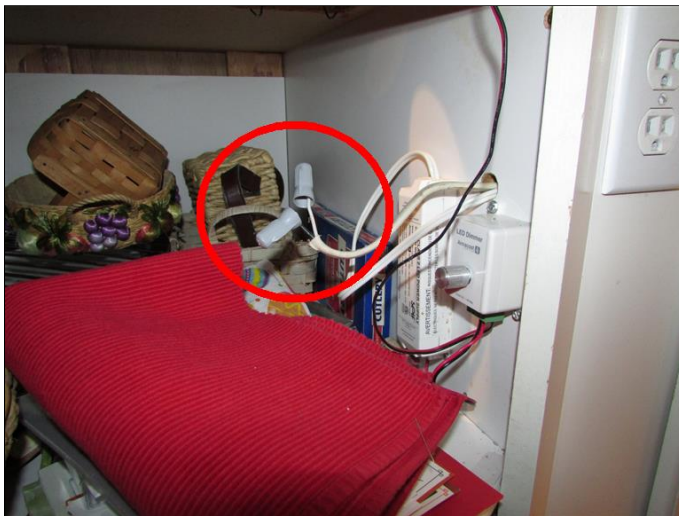
(1) There was improperly terminated electrical wiring underneath the kitchen island countertop, creating a potential shock hazard. Have the wires properly terminated inside an electric box.

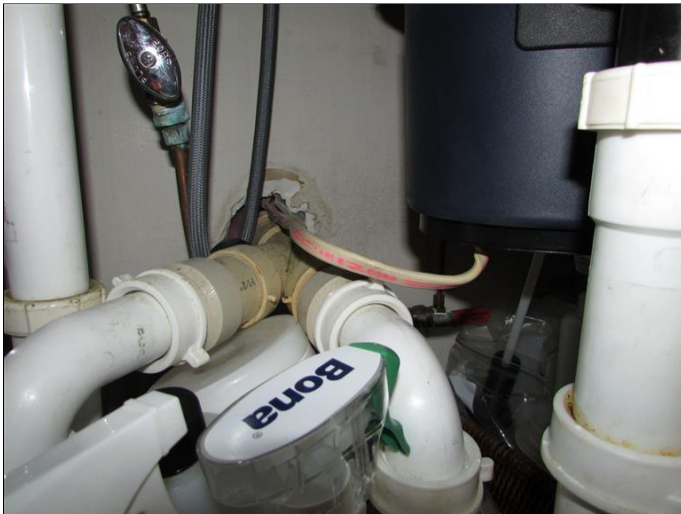
- (3) The non-metallic cable for the garbage disposer at the kitchen sink should be protected in a flexible metal conduit. This will help prevent damage to the wire from items being moved under the kitchen sink. Have this corrected.

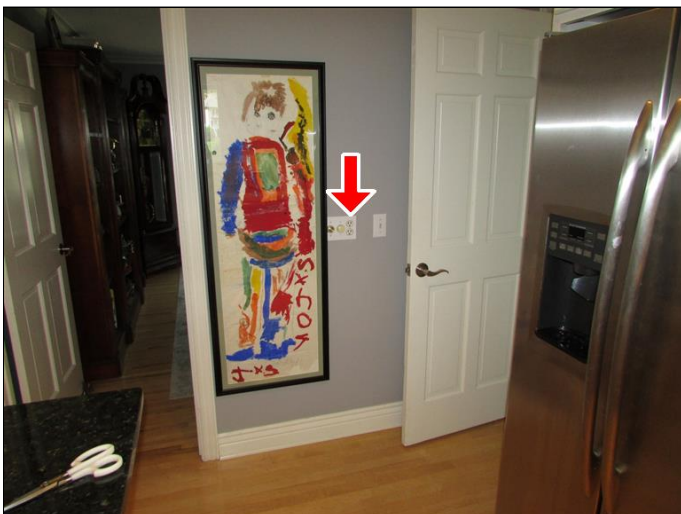
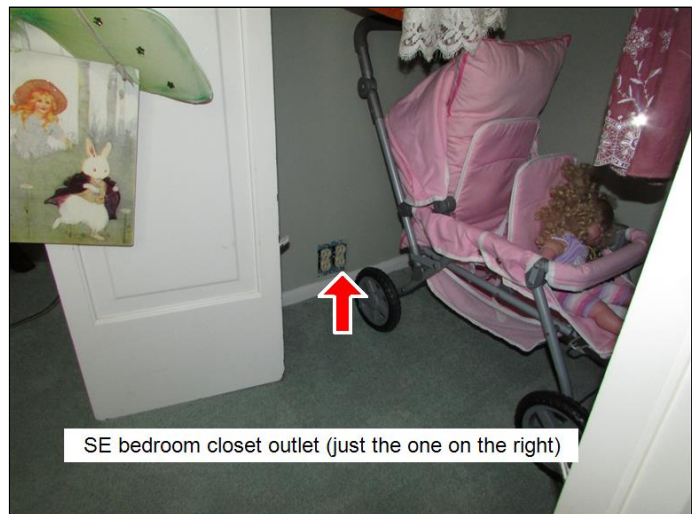
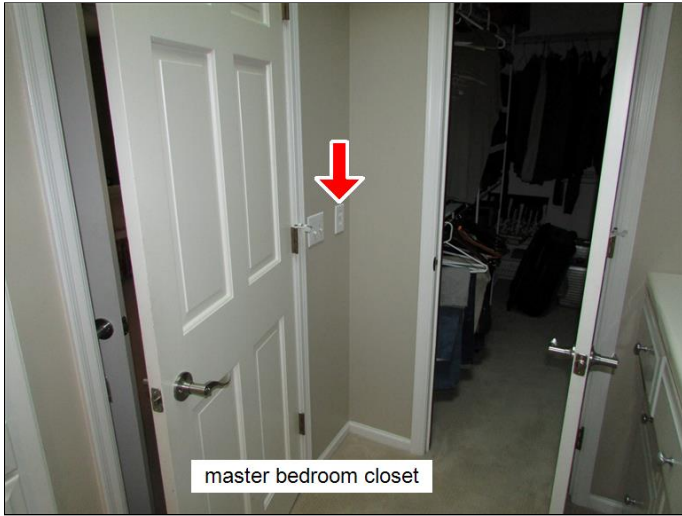
- (4) There were several [ungrounded three prong outlets](#) present, indicated in the photos below. These are potential shock hazards, and can allow equipment that is plugged into these outlets to be damaged. Have the wiring corrected.

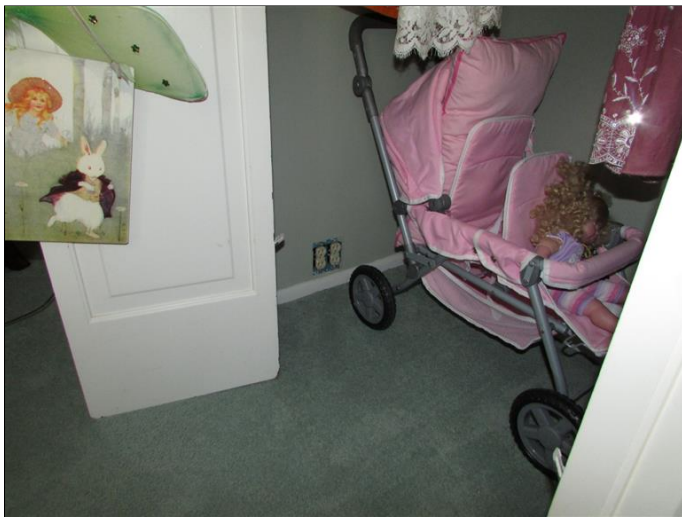
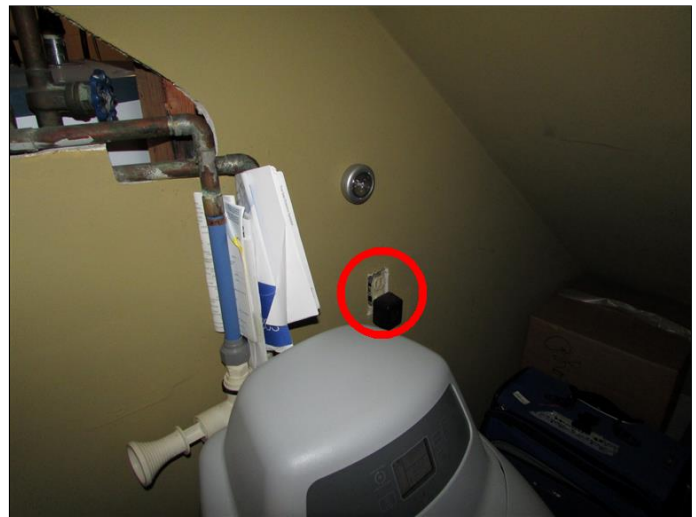
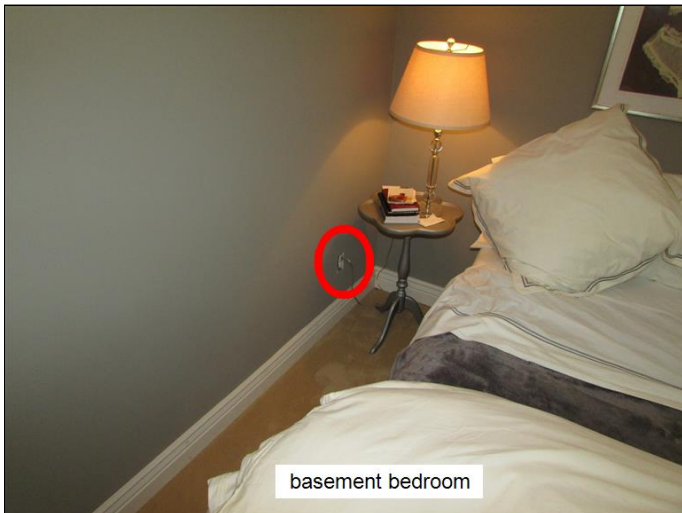
(5) There were cover plates missing at several outlets, creating shock hazards. Replace the missing cover plates.

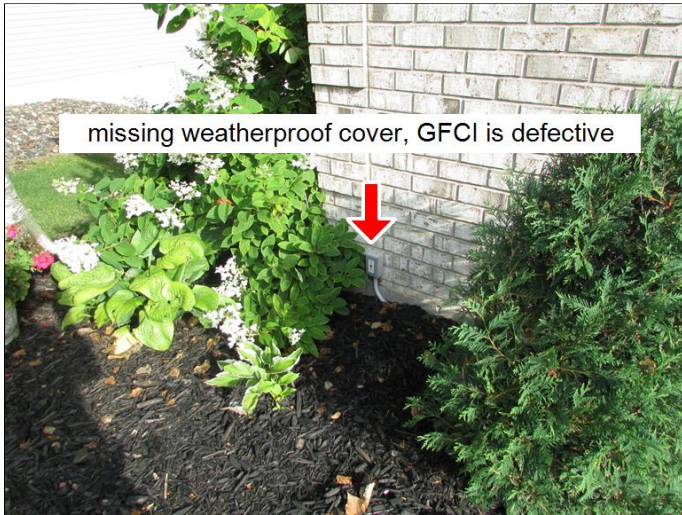
- +** (2) The GFCI outlet at the SW corner of the house at the exterior was defective - it did not trip with the built-in test button. Have this outlet replaced to lower the risk of a lethal shock. Once this is done, verify the other exterior outlets are GFCI protected.

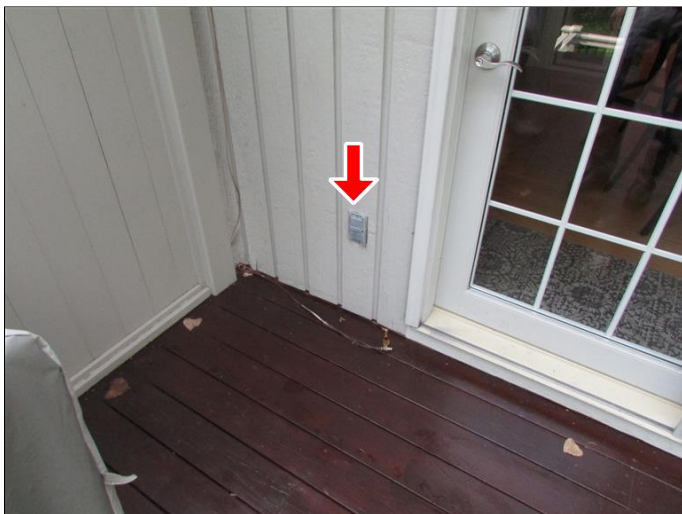
- +** (3) The deck GFCI outlet was improperly wired; the device tripped with the test button, but did not lose current. This will happen if the line and load are reversed on older GFCI outlets. Have the wiring repaired to lower the risk of a lethal shock.

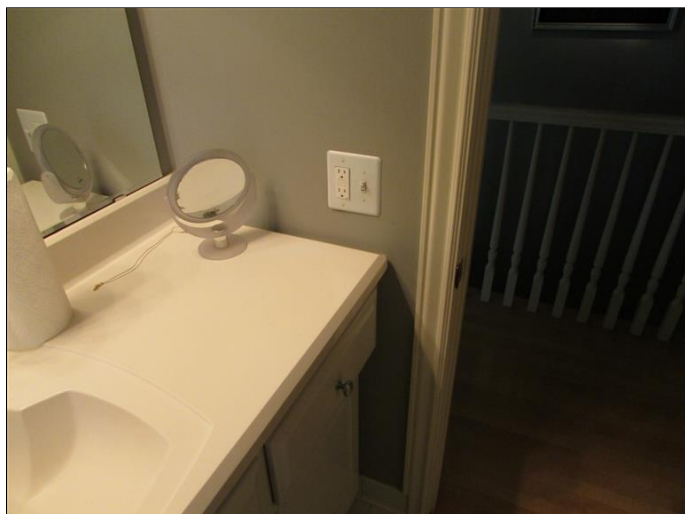
- +** (4) The GFCI outlet in the first floor hallway bathroom was tripped and would not reset. Have the tripped outlet replaced.

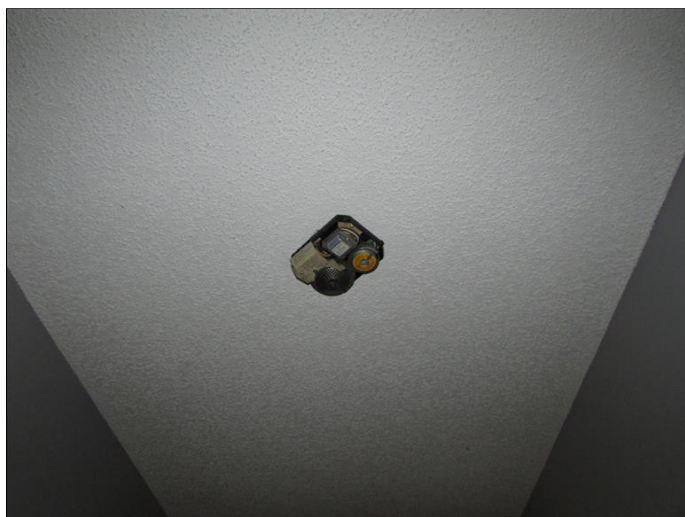
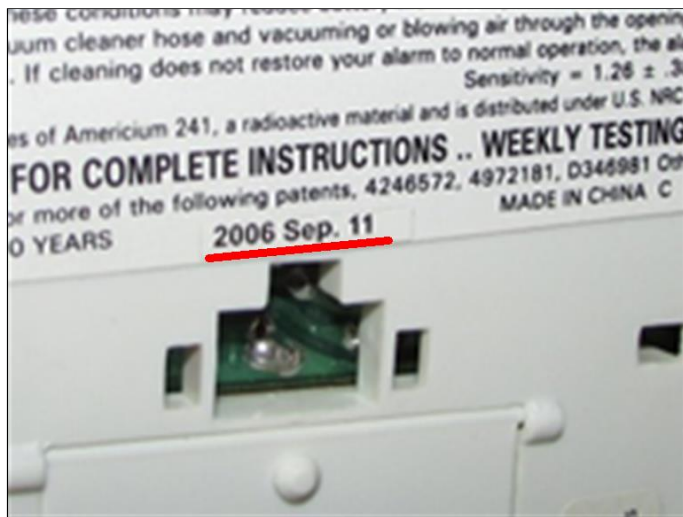
- +** The smoke alarms were over ten years old, and should be replaced. Smoke alarms are designed to last only ten years. Install photoelectric smoke alarms. Do not use ionization-only smoke alarms. For more information on this topic, click here: [Photoelectric smoke alarms are all you need.](#)

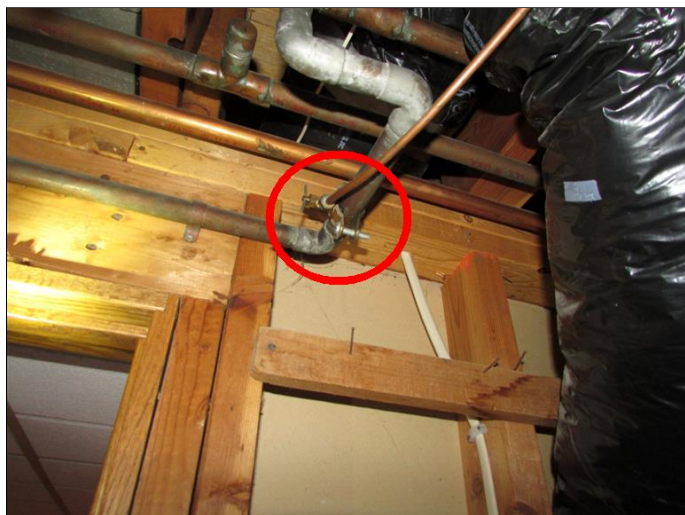
- There was a [saddle valve](#) present to supply water to the whole house humidifier. Saddle valves are not approved for use in Minnesota and are prone to leakage. Try to avoid operating this valve. If it leaks when operated, have it replaced.

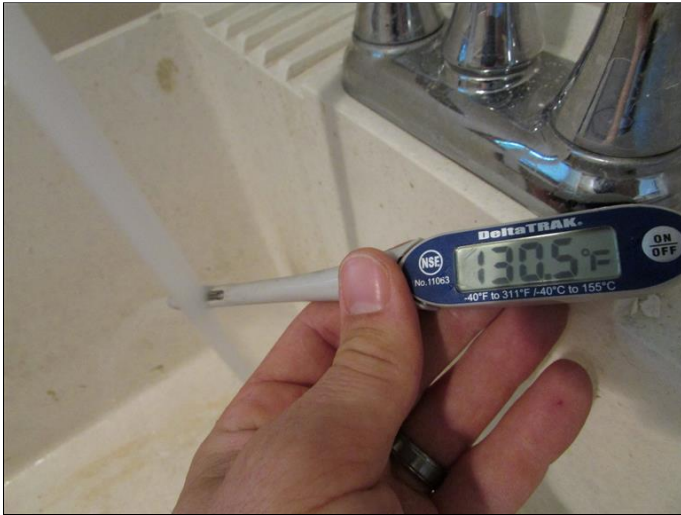
- i** The hot water coming out of the faucets was measured at approximately 130 degrees, which can cause scalding very quickly. The temperature of the water shouldn't be higher than 120 degrees at any of the faucets. To reduce the risk of scalding, turn the temperature down at the water heater. Be aware, however, that this will increase the potential for Legionellae Bacteria growth. To minimize the risk of scalding and bacteria growth, have a tempering valve installed. For more info on this topic, click here: [Water Heater Temperature](#).

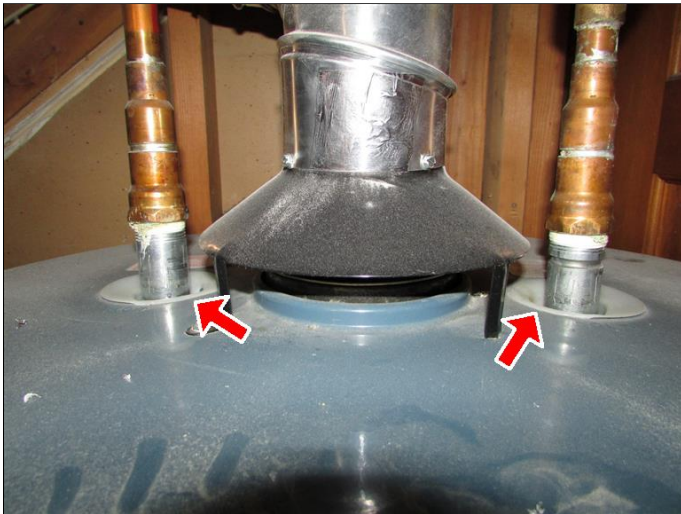
- i** There was some melted plastic at the water lines near the draft hood, which is an indication that the water heater has backdrafted. The water heater drafted properly at the time of the inspection, even with the bath fans, kitchen downdraft, and dryer turned on.

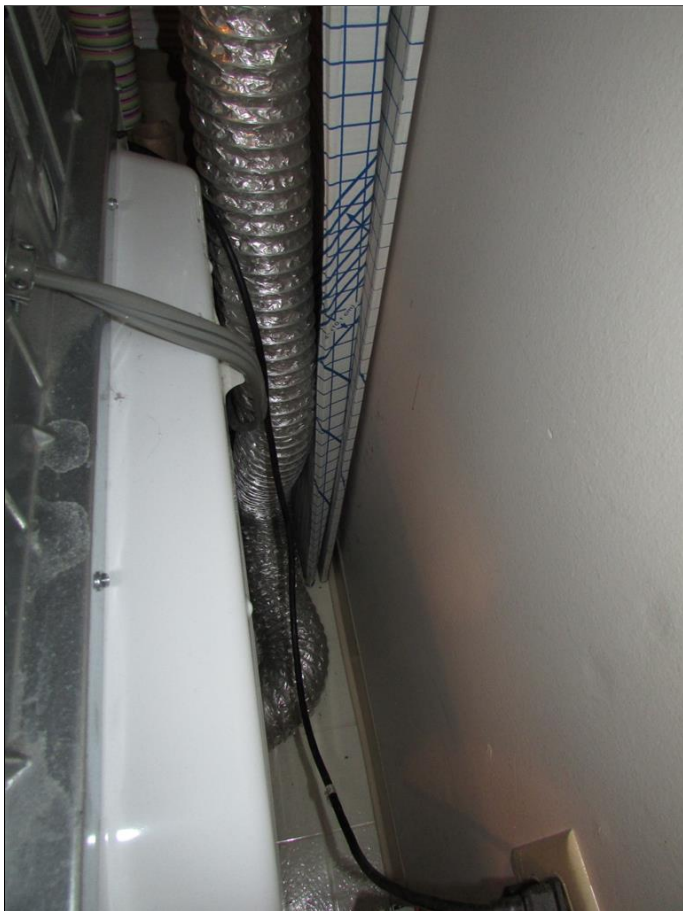
- There was a bunched up section of [flexible dryer duct](#) material behind the dryer. This compromises the performance of the clothes dryer and creates a fire hazard. Have the dryer transition duct made as short as possible for improved performance and safety.

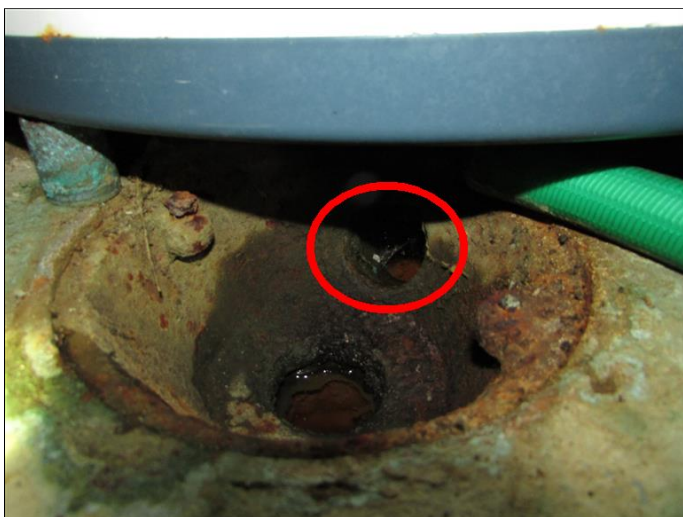
- The cleanout plug at the floor drain was missing, which will allow hazardous, smelly sewer gases to enter the home. Cleanout plugs are usually removed because of a clogged drain. Install a cleanout plug and have the drain cleaned out. Sometimes the clogs can not be fixed, and the drain may need replacement. For more detailed information on this topic, click here: [Floor Drain Basics](#)

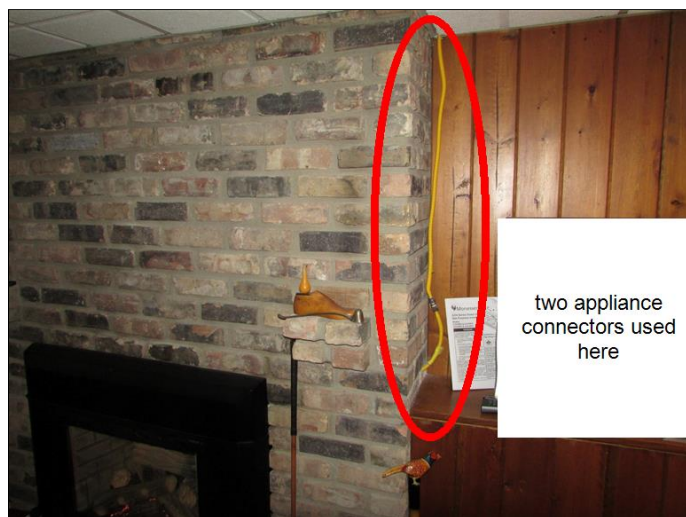
There were two flexible appliance connectors in use for the basement fireplace; flexible appliance connectors are used to connect the appliance to the hard piped gas line, not in place of permanent gas piping. The appliance connectors also shouldn't penetrate the fireplace walls and ceiling. Have this corrected to reduce the potential for a gas leak. Click this link for more information on this topic: [Gas Appliance Connectors](#)

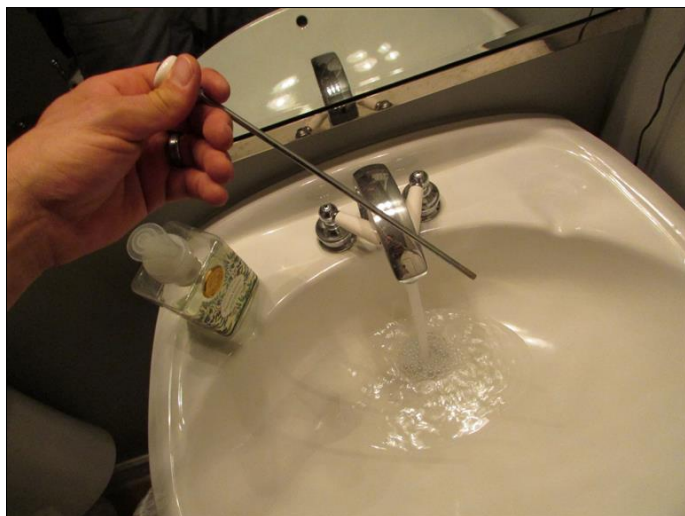
The mechanical sink stopper in the powder room bathroom did not function and will need to be serviced to work properly.
