## Structure Tech Home Inspections

# Inspection Report

**Property Address:**  
12345 Happy Lane  
Minneapolis MN

<b>Date:</b> 8/15/2017	<b>Time:</b> 08:30 AM	<b>Report ID:</b>
<b>Property:</b> 12345 Happy Lane Minneapolis MN	<b>Customer:</b> Experienced Home Buyer	<b>Real Estate Professional:</b>

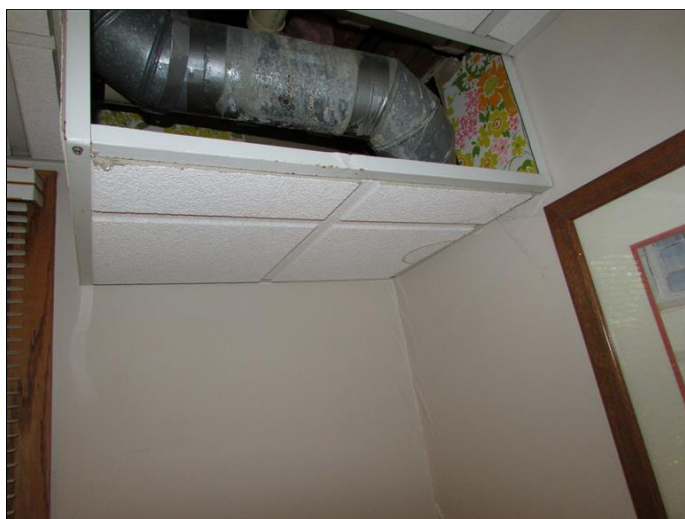
- i There were moisture stains at the ceiling panels in the laundry room, pictured below. There was rusted ductwork above as well as some drain lines. There was no currently dampness, even after running a lot of water in the plumbing fixtures above. The stains are likely the result of condensation in the ductwork. If the staining re-occurs or continues, consult with an HVAC contractor for ways to prevent condensation in the ductwork at this location.

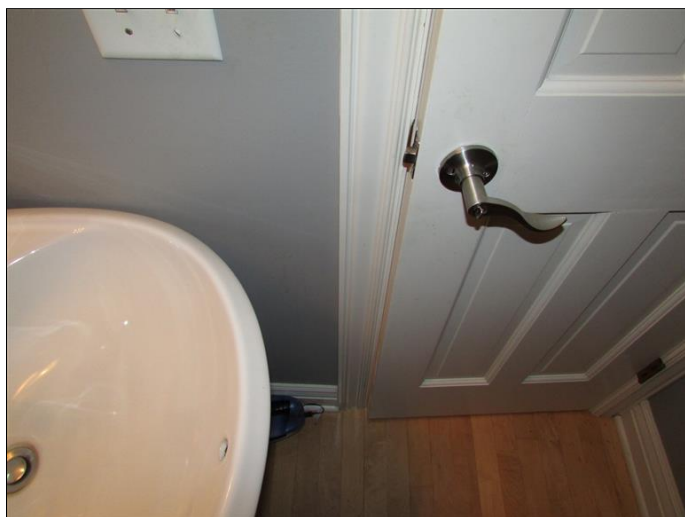
- The power room bathroom door rubs on the jamb, which is a nuisance. Sand or plane the door down to prevent this from happening.

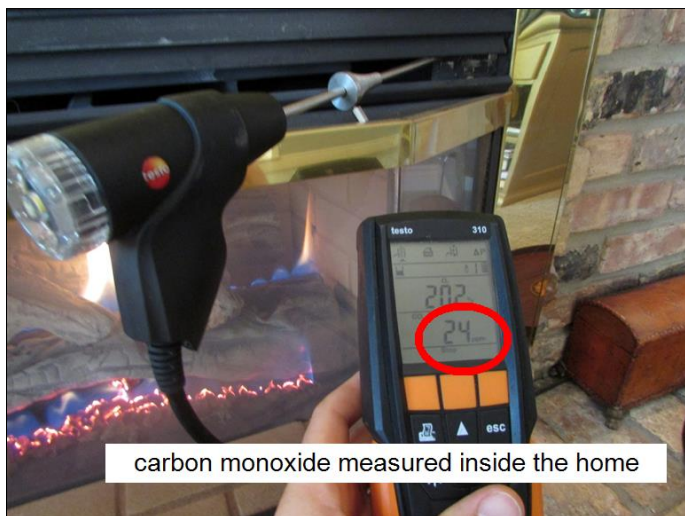
- There was exhaust gas leaking back into the home at the first floor gas fireplace. This is a safety hazard. Have the gas fireplace repaired before using it.

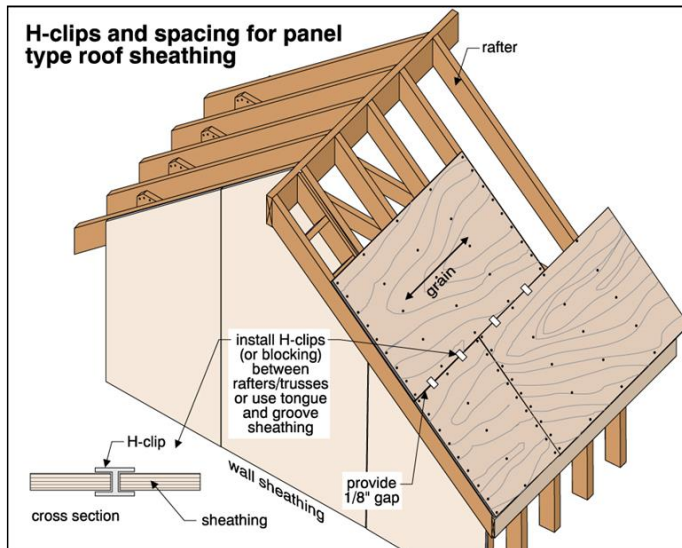
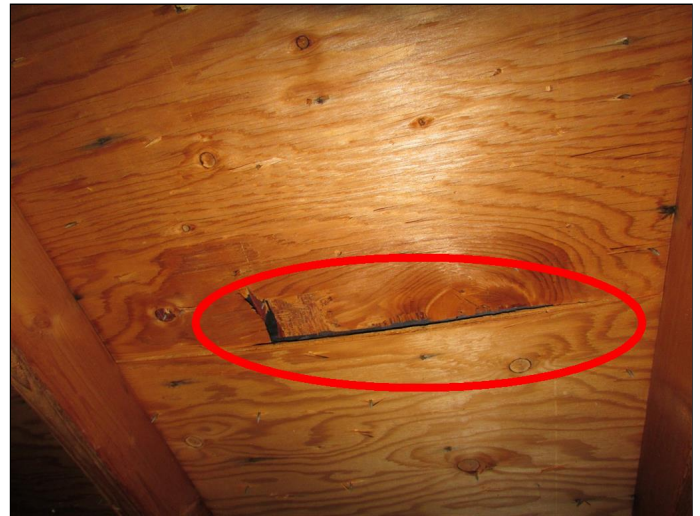
- (1) There were no "H" clips at the roof sheathing. These are used today to help prevent the sheathing from sagging. Some of the areas had offsets in the sheathing. There is no required service, however.

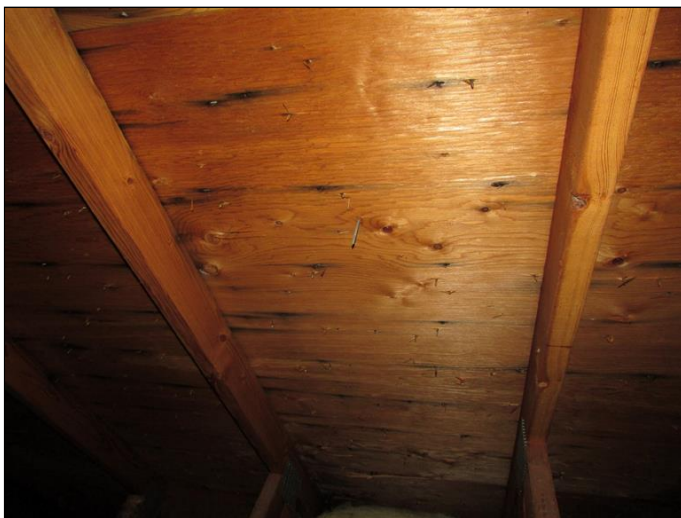
- (2) There were light black stains on the roof sheathing around the nail heads. This staining is caused by condensation in the attic. To help reduce condensation in the attic, the humidity levels in the home will need to be reduced, and the passageways for this moisture to get in to the attic need to be sealed; these passageways are called 'attic bypasses'. Simply keeping the whole-house humidifier turned off may be enough to prevent further condensation in the attic.

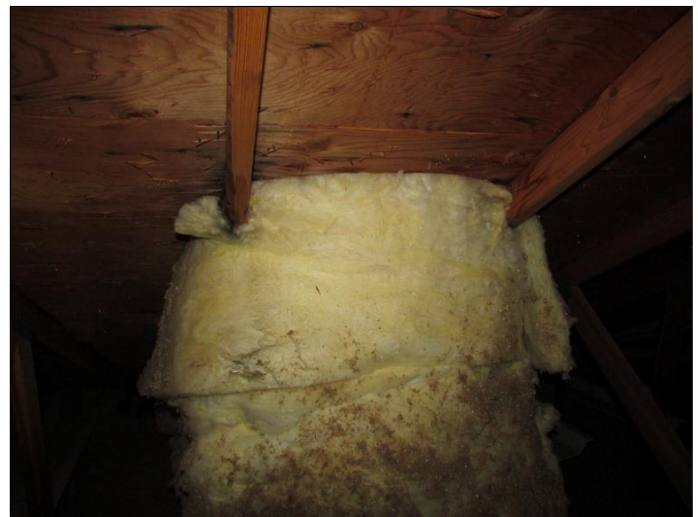
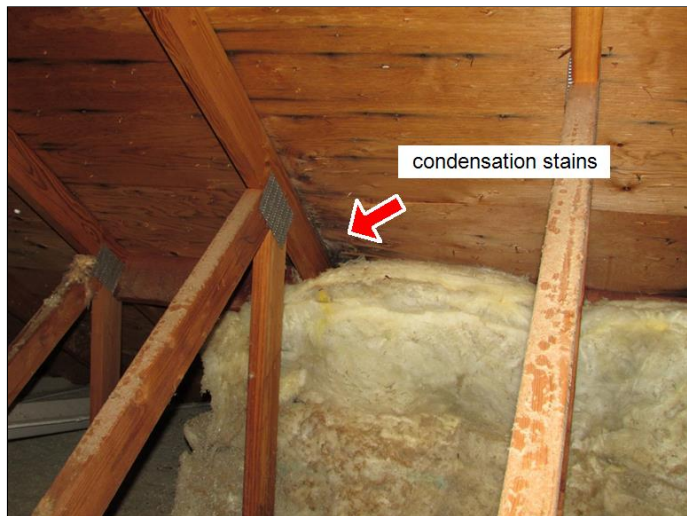
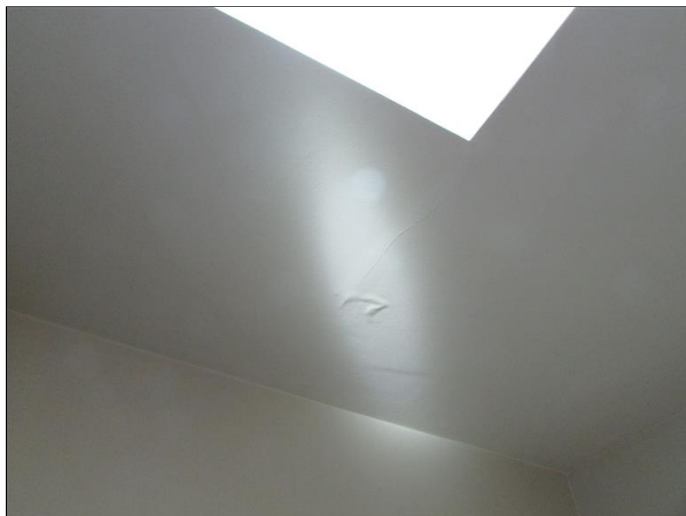
(1) The skylight shafts were insulated with fiberglass batts, but there were no air barriers installed on the attic sides of the insulation. This will allow for convective air movement through the insulation, making for cold skylight shaft walls. This increases the potential for condensation, which is often confused with skylight leaks. If condensation and staining occurs around the skylights, the fix would be to re-insulate the skylights with an air-impermeable material, or to enclose the shafts with an air barrier on the attic side. For more information on this topic, click the following link:

There were signs of past staining and condensation around both skylights.

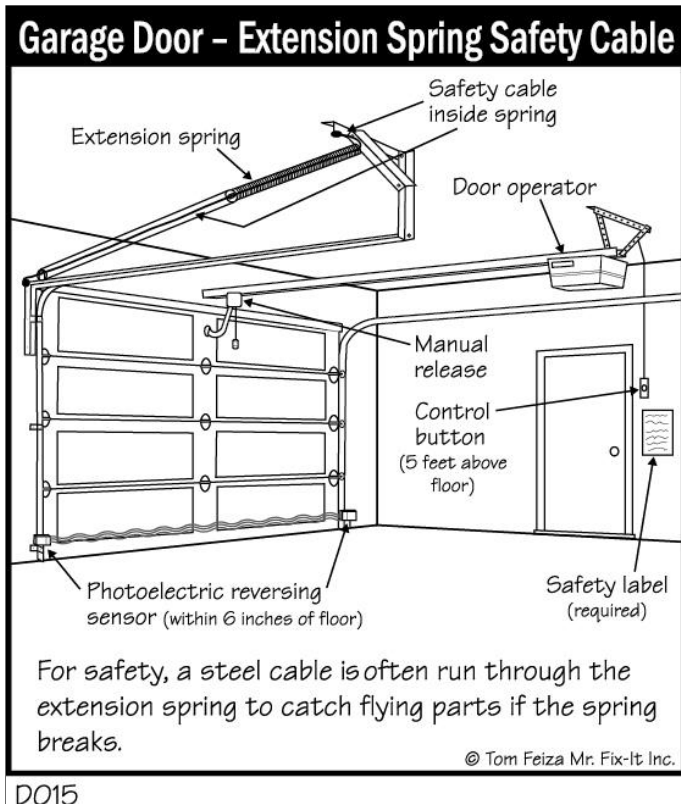
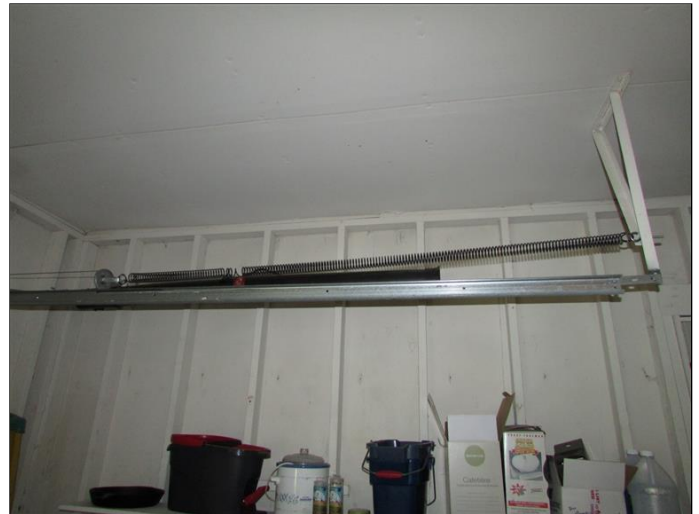
- +** (1) If one of the overhead door springs broke, it could injure someone. Install [safety cables](#) for the springs to traverse along to help prevent a possible injury.

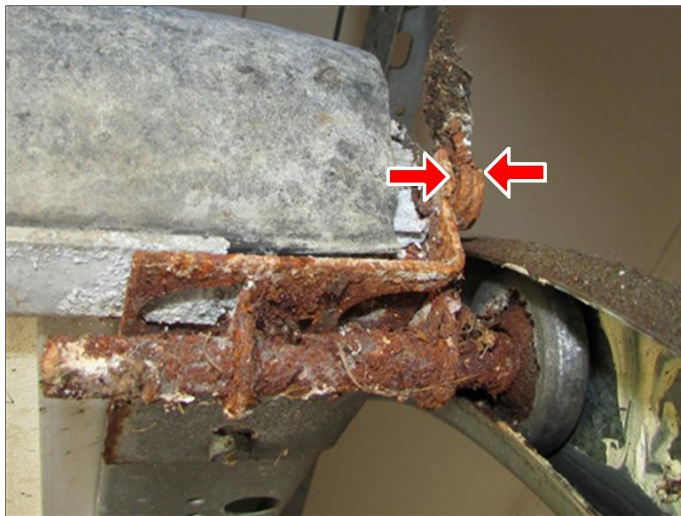
- 🔧** (2) The east overhead garage door had a rusted cable at the bottom of the east end of the door. Have this cable replaced before it breaks.

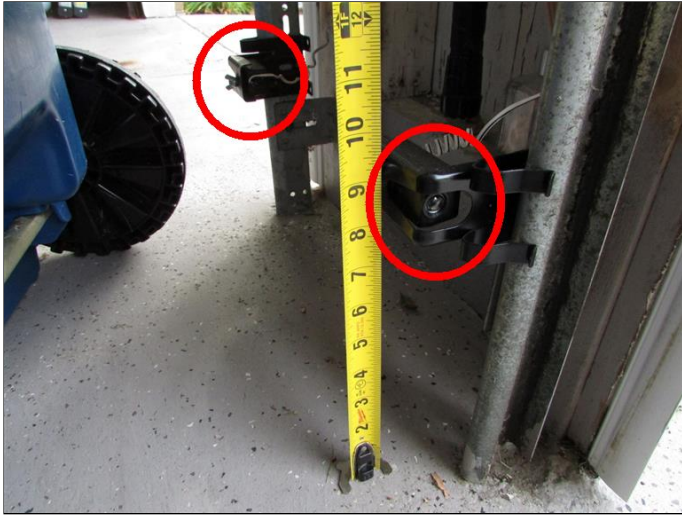
**+** The safety-reverse sensors for the garage door opener were located higher than six inches above the floor, which is the maximum allowable height. This can be a safety hazard should a small child or animal be on the floor under the door. Lower the sensors for safety.

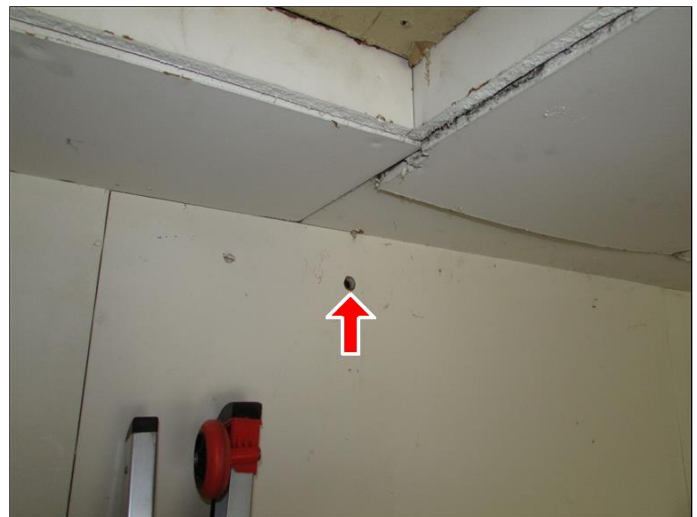
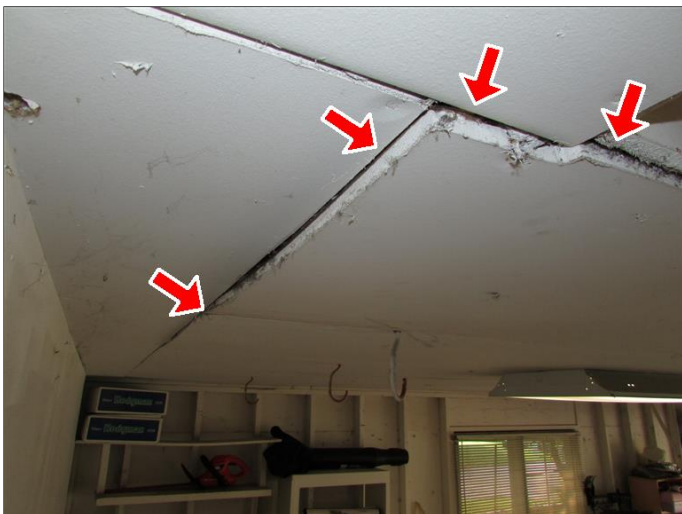
**🔄** There were voids in the garage / house wall that should be repaired, in order to maintain the necessary fire separation between the garage and the living quarters.
