Structure Tech Home Inspections

Inspection Report

Property Address:
12345 Super Happy Street
Minneapolis MN

Date: 9/21/2015	Time: 09:00 AM	Report ID:
Property: 12345 Super Happy Street Minneapolis MN	Customer: New Buyer	Real Estate Professional:

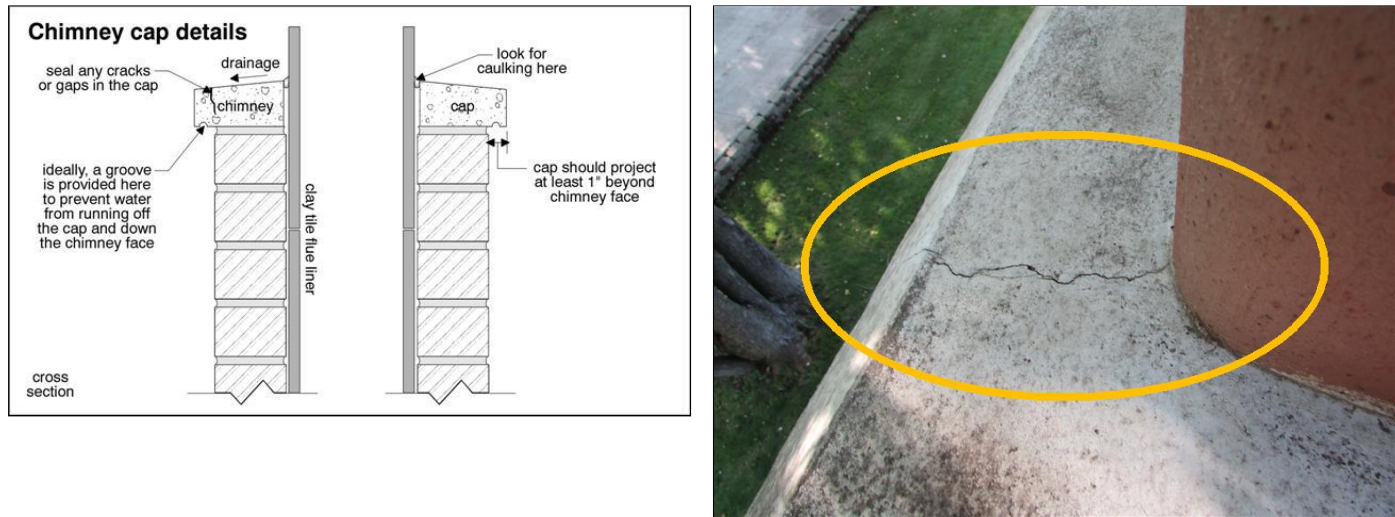
2.0 Chimney Crown

The chimney crown was cracked. These cracks will allow water into the chimney and should be sealed to help prevent damage to the chimney.

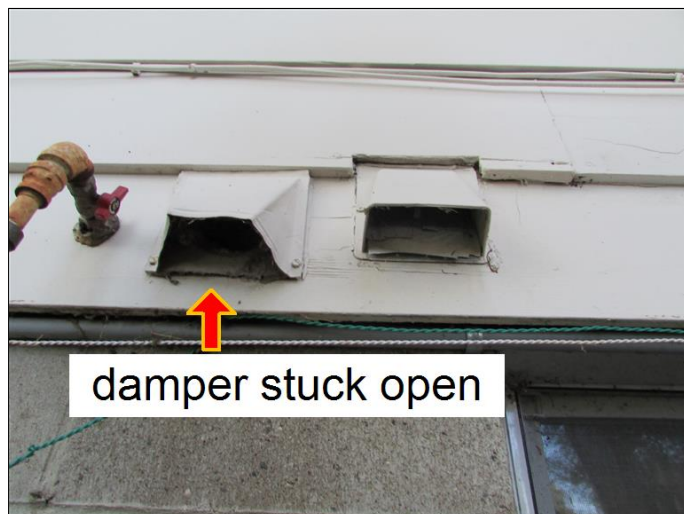
3.2 Vent Terminals / Intakes

There were two abandoned bath or dryer vent terminals at the north side of the house. The damper was open on one which will allow for cold air to come in house. Have both vent terminals properly sealed at the exterior.

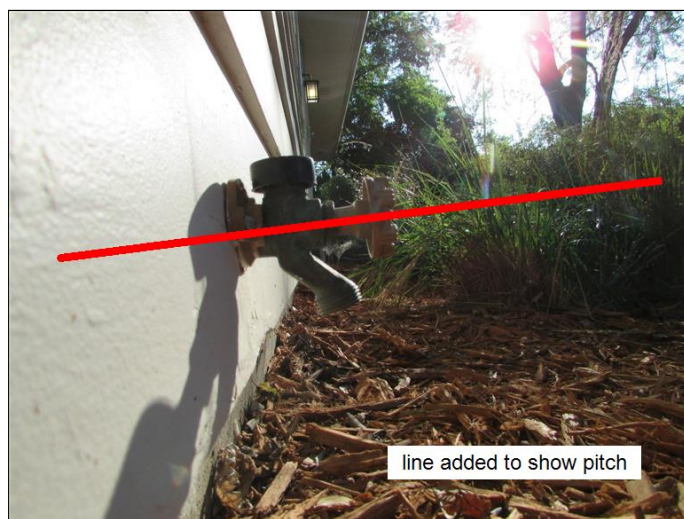
3.3 Exterior Faucet(s)

The frost-free faucet at the front side of the house was improperly installed; if the faucet doesn't slope downwards towards the spout, the water won't drain out when the faucet is turned off. If the water doesn't drain out, it has the potential to freeze and destroy the faucet, or possibly cause a leak from a burst pipe inside the house. Have this installation repaired. For more info about this specific defect here: <http://www.structuretech1.com/2012/01/how-to-prevent-outside-faucets-from-freezing/>

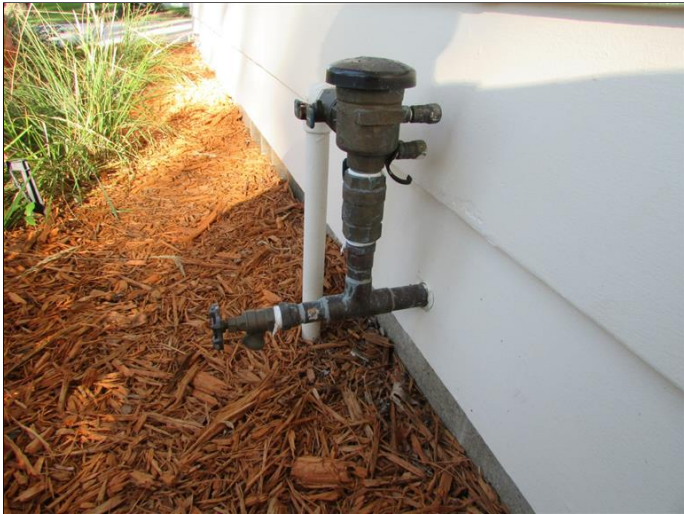
3.4 Exterior Faucet(s)

There was no backflow prevention device at the front exterior faucet pictured below. These are required to protect the potable (drinking) water supply from contamination. Add a vacuum breaker at the exterior faucet. For more information on this topic, click here: [Why do I need a backflow preventer?](#)

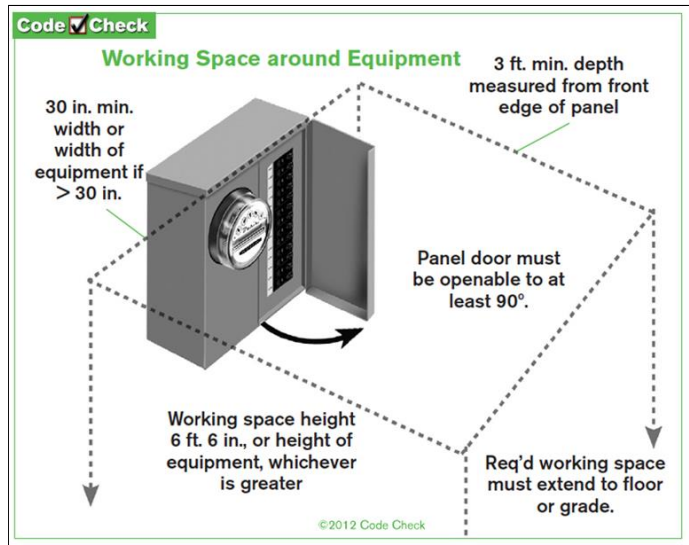
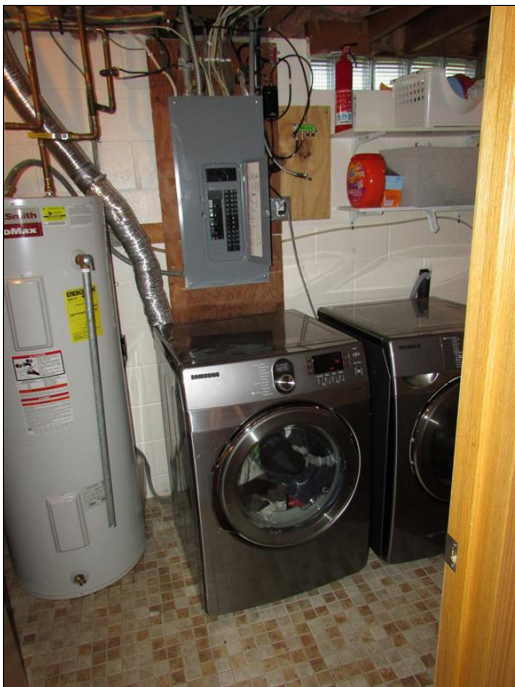
5.0 Main Panel

The main panel did not have thirty-six inches of clear space in front of it, which is the minimum required working space.

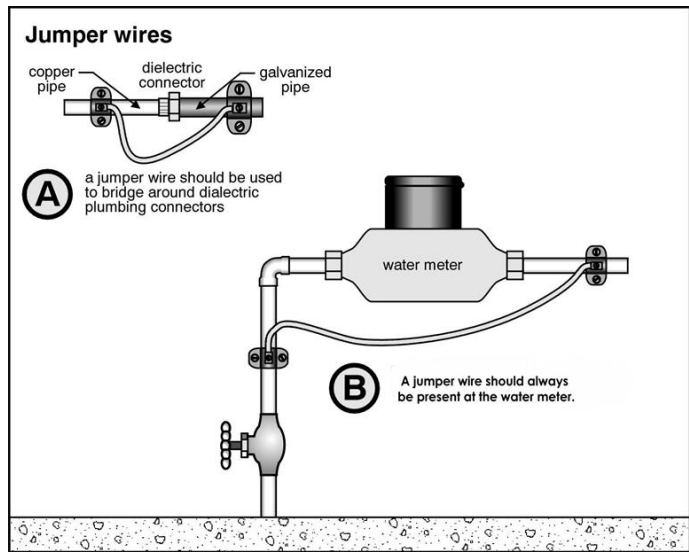
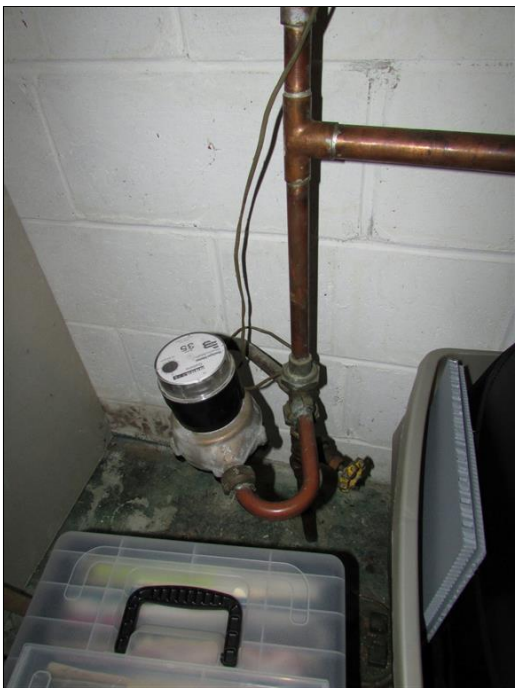
5.1 Service Grounding & Bonding

The main electric service was only grounded to the water distribution piping in the same room as the panel. For added safety, I recommend having this main panel grounded to the water piping coming into the home before the meter, including a [ground jumper](#).

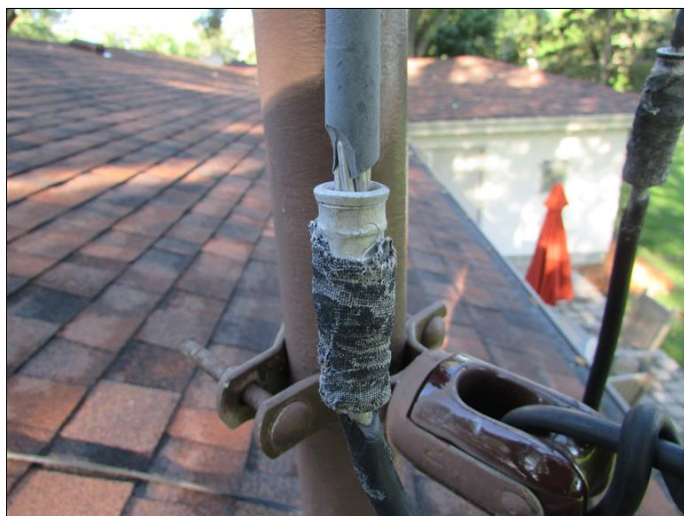
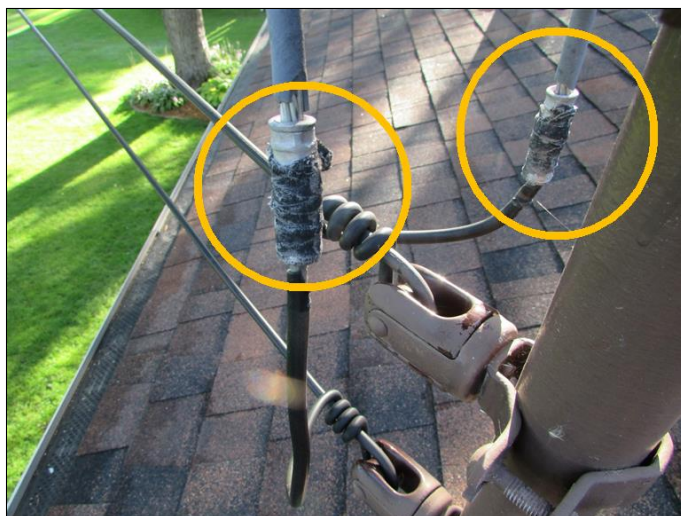
5.2 Exterior Electrical

The clamps at the service entrance conductors weren't properly insulated, which is a shock hazard. If someone touched them, they would get shocked or electrocuted. Have the [utility company](#) correct this.

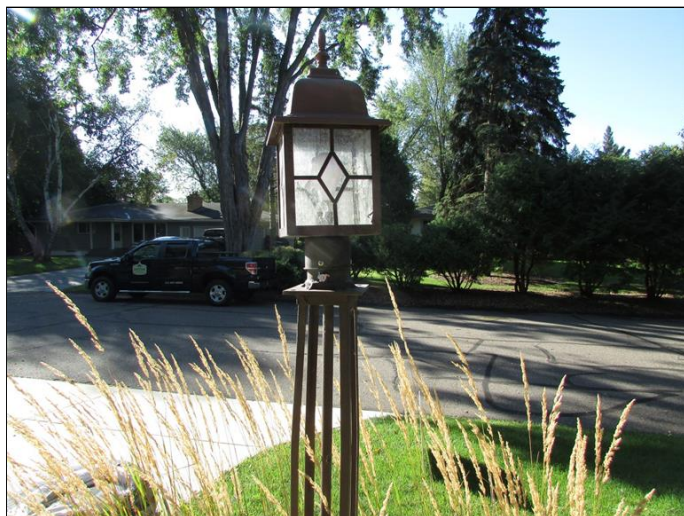
5.3 Exterior Electrical

The front yard light did not function. This may be the result of a burned out bulb, the light could be controlled by a photoelectric sensor, or there may be a problem with the wiring. Try replacing the bulb first.

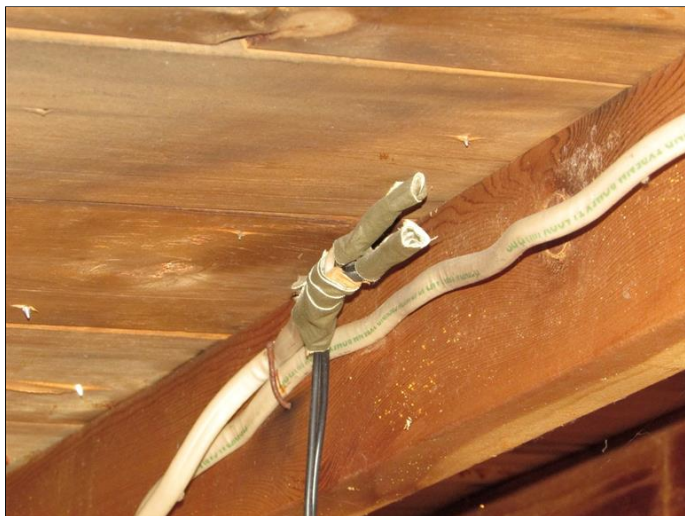
(1) There was an open electrical splice in the attic, which is a potential fire hazard. Splices need to be made inside of junction boxes to contain any arcing or sparking which could occur. Have this repaired by an electrician.

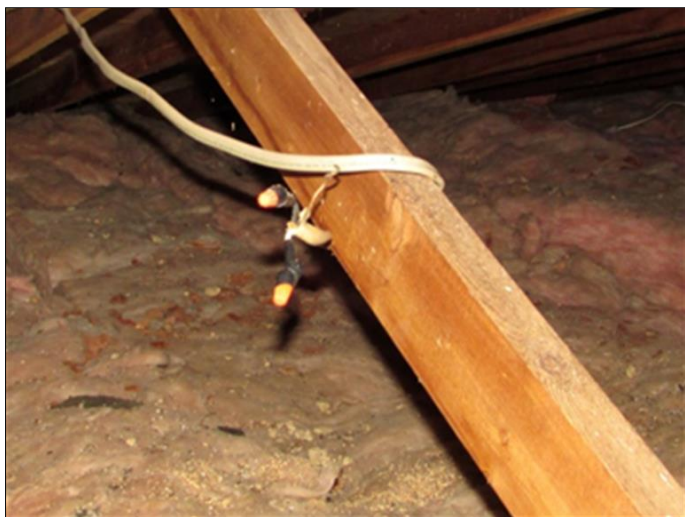
(2) There was one improperly terminated cable in the attic, which is a potential shock and fire hazard. Remove this cable or have it properly terminated inside a box.

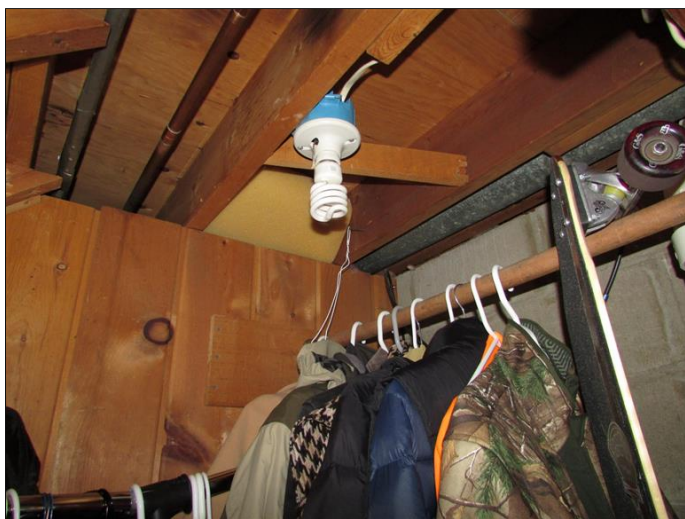
(3) There was a bare bulb light in the basement closet, creating a potential fire hazard. Install a light with a protective globe.

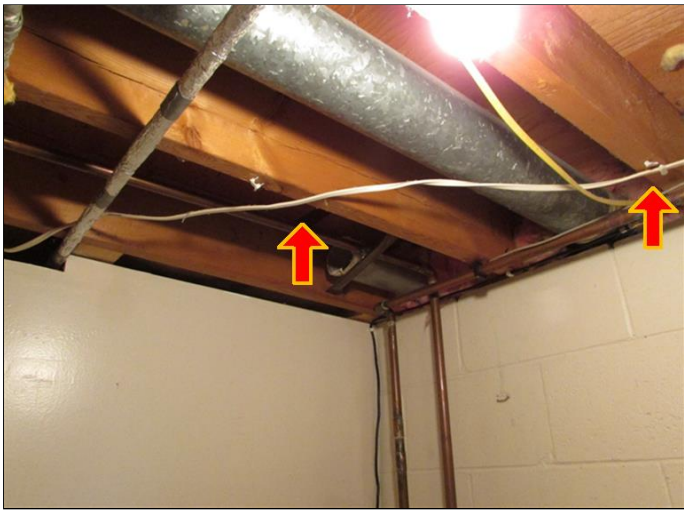
(4) There was some NM cable (or Romex) that was improperly stapled to the bottom of the floor joists; this size wire should be fed through bore holes in the floor joists, not mounted underneath.

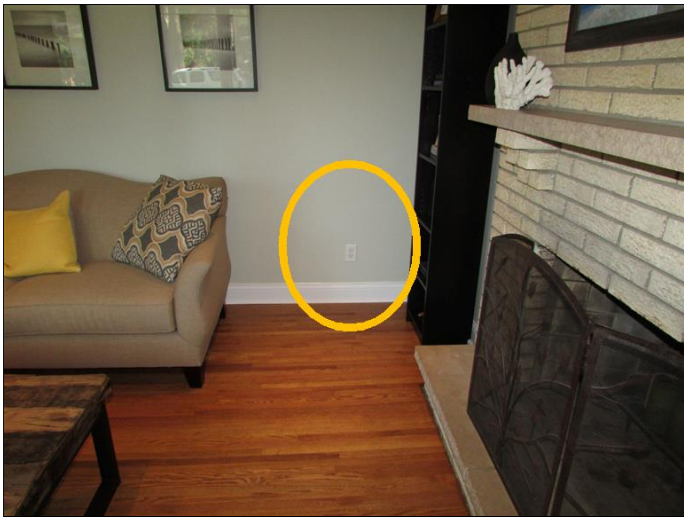
North living room wall

(1) There were several [ungrounded three prong outlets](#) present, indicated in the photos below. These are potential shock hazards, and can allow equipment that is plugged into these outlets to be damaged. Have the wiring corrected.

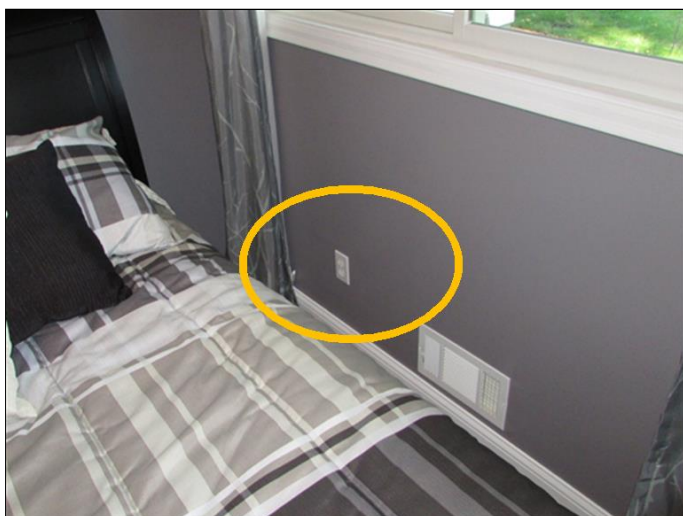
(2) There was [reversed polarity](#) to the north wall outlet in the northwest bedroom. This means that the hot and neutral wires have been wired backwards at some point in between or at the main service panel and the outlet. This is a shock hazard. Have the wiring repaired.

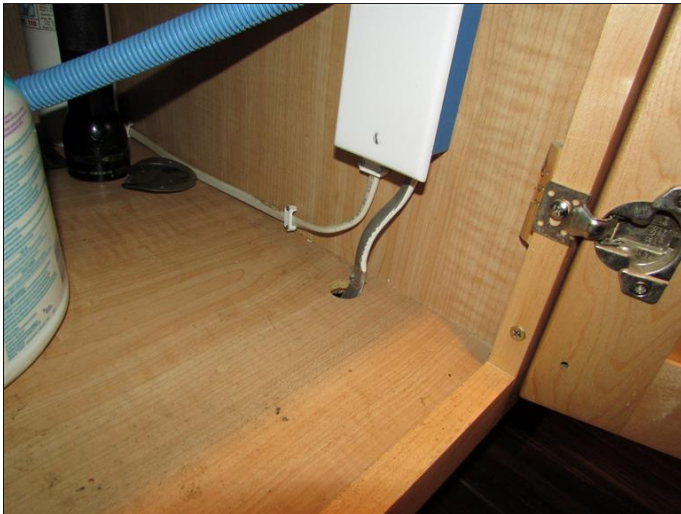
(3) The surface mounted non-metallic cable under the kitchen sink should be protected in a metal raceway or something similar to help prevent physical damage. This was not done.

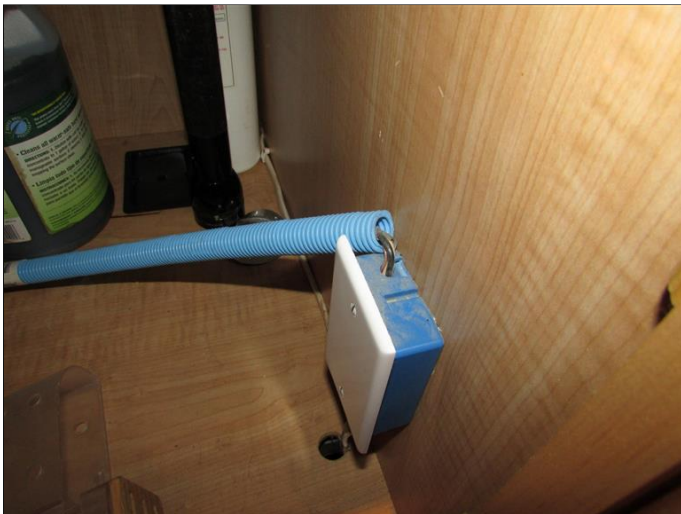
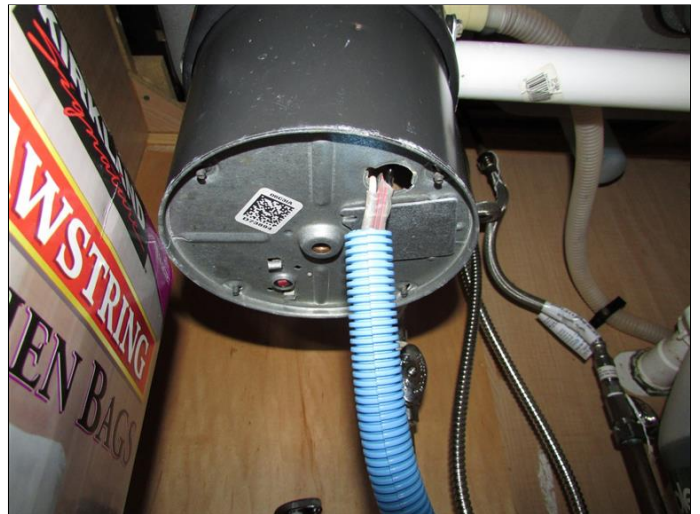
(4) The non-metallic cable for the garbage disposer at the kitchen sink should be protected in a flexible metal conduit and secured at the disposer, to help prevent damage to the wire from items being moved under the kitchen sink. Have the wiring to the disposer re-done for safety.

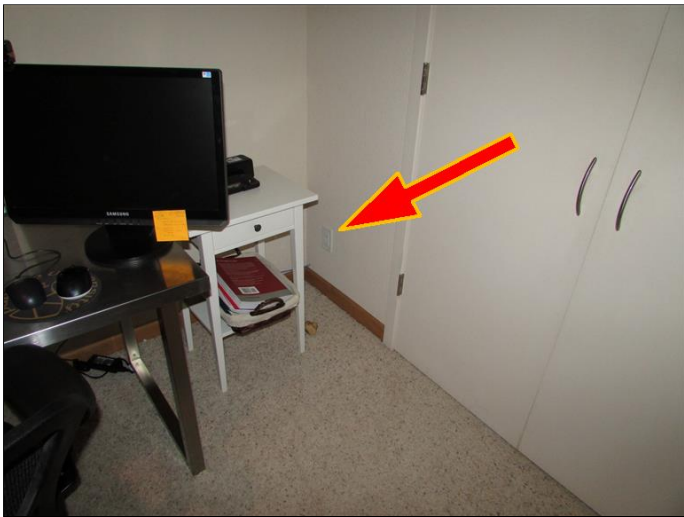
(2) The GFCI outlet in the basement office room tripped, but did not lose current. This is not a location that requires GFCI protection, however, the outlet was not grounded, and our recommendation is to correct the wiring.

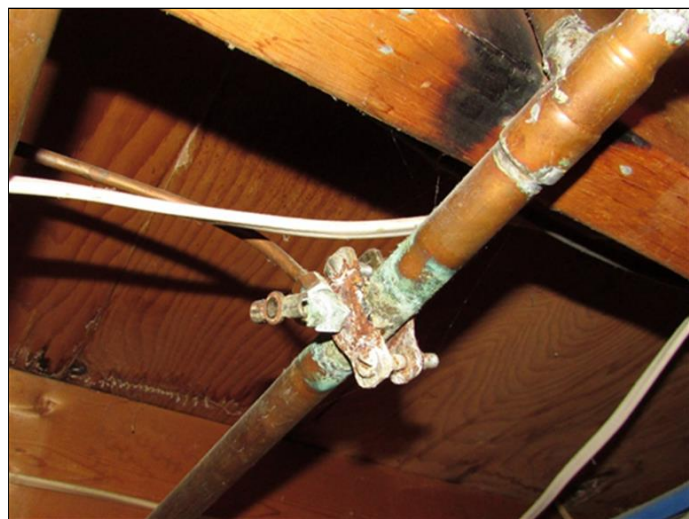
6.0 Water Distribution Piping

There was a [saddle valve](#) present to supply water to a whole house humidifier, but the humidifier has since been removed. Saddle valves are not approved for use in Minnesota and are prone to leakage. This saddle valve was heavily corroded and should be removed, and the pipe repaired. There was also a saddle valve present for the ice maker; try to avoid operating that valve.

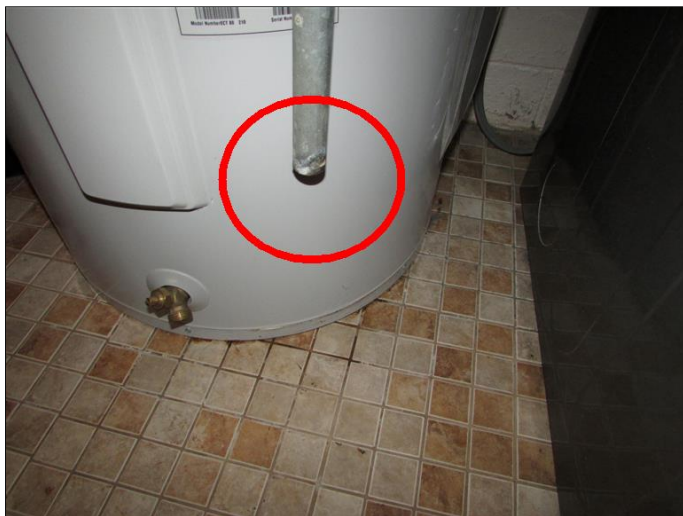
(1) The temperature and pressure relief valve at the water heater leaked, and should be replaced. If the valve leaks again after replacing it, this would need further evaluation by a plumber to help determine the cause for the leaking. For more information on this topic, click here: [Why The Relief Valve at the Water Heater is Leaking](#)

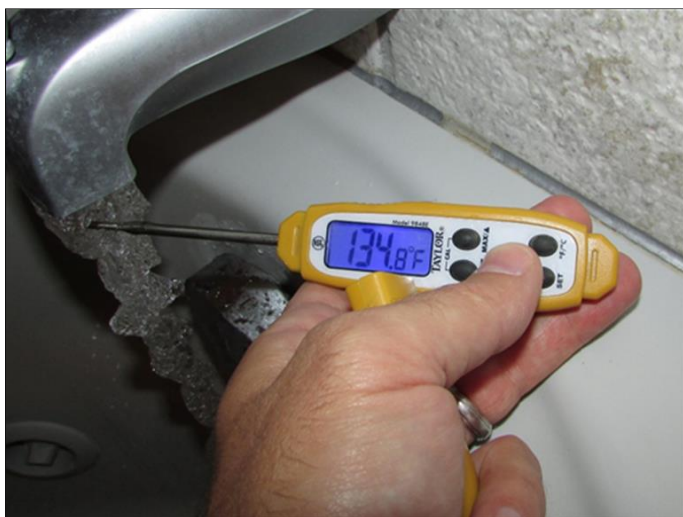
(2) The hot water coming out of the faucets was measured at approximately 135 degrees, which can cause scalding very quickly. The temperature of the water shouldn't be higher than 120 degrees at any of the faucets. To reduce the risk of scalding, turn the temperature down at the water heater. Be aware, however, that this will increase the potential for Legionellae Bacteria growth. To minimize the risk of scalding and bacteria growth, have a tempering valve installed. For more info on this topic, click here: [Water Heater Temperature](#).

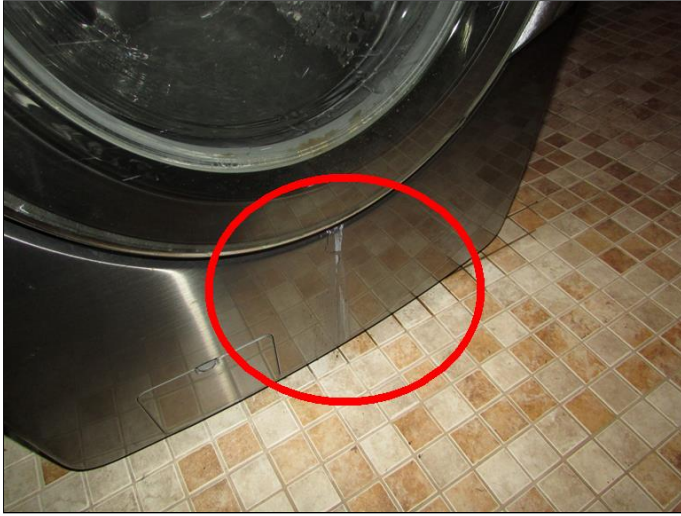
6.2 Clothes Washer/Dryer

The front loading washing machine has a rubber gasket that can build up with mold growth. Keep the door open a crack when not using it to keep the gasket dry. Clean it now.

The washing machine leaked at the front door, and should be serviced.

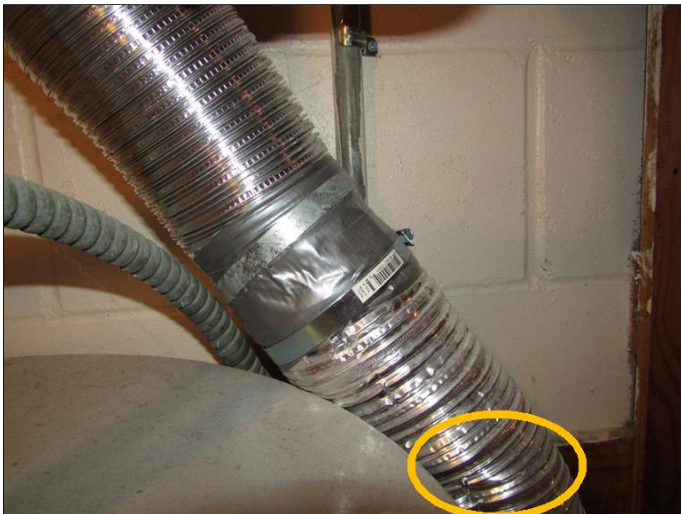
6.3 Dryer Duct

The dryer duct consists of a semi-rigid aluminum material that was improperly spliced using duct tape and clamps at the joint pictured. This material also does not return to its original shape when dented. Dents impede air flow and could potentially lead to a fire from lint accumulation. Flexible material should only be used to connect the dryer to the rigid metal duct; never as a substitute for metal ductwork. Have the flexible material replaced with smooth metal to lower the potential for a fire.

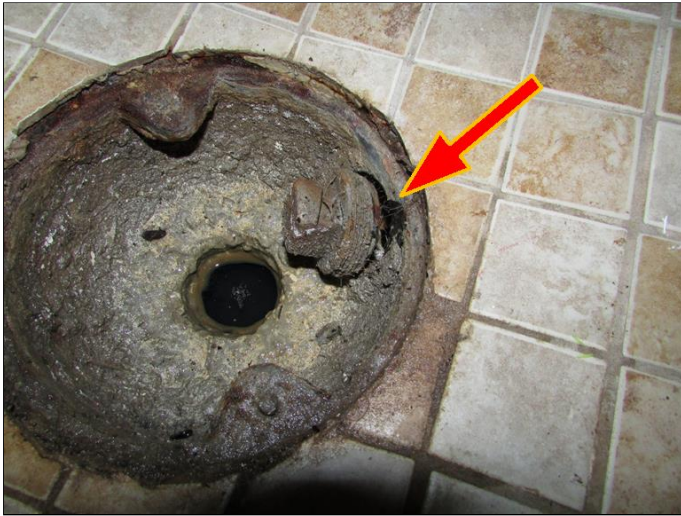
6.4 Floor Drains

There was a loose cleanout plug at the floor drain, which will allow hazardous, smelly sewer gases to enter the home. Secure the cleanout plug or have it replaced with a tight-fitting plug. For more detailed information on this topic, click here: [Floor Drain Basics](#)

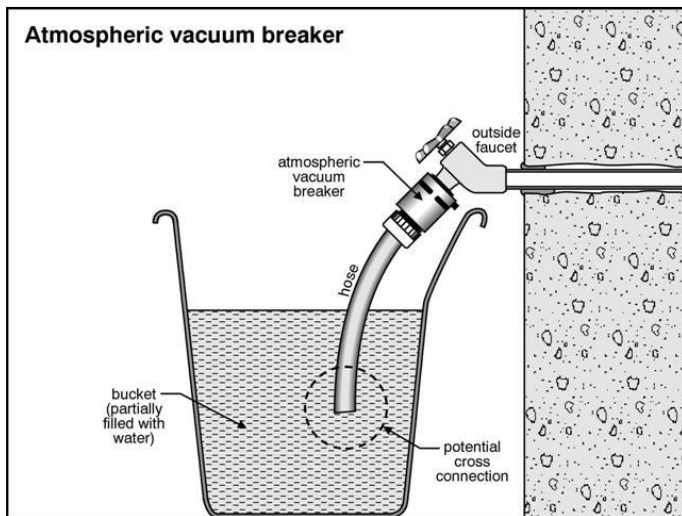
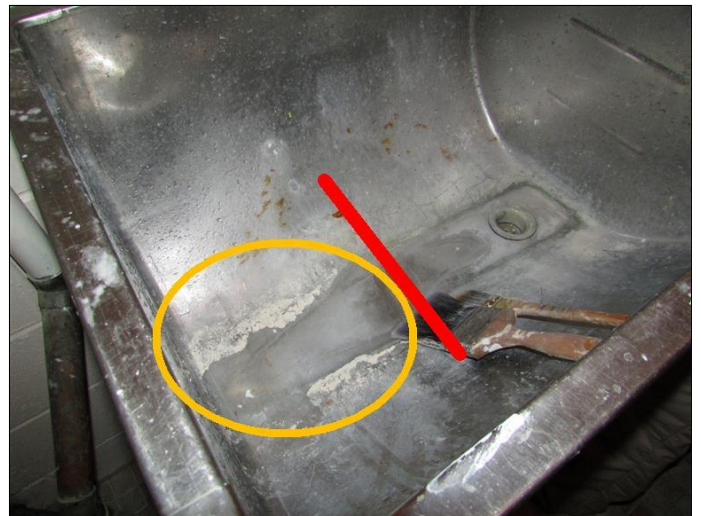
The sink was dented from below causing a high spot in the middle of the sink. This "ridge" prevents water from completely draining. Repair the dent to allow the sink to drain properly.

ponds in circle, line represents ridge

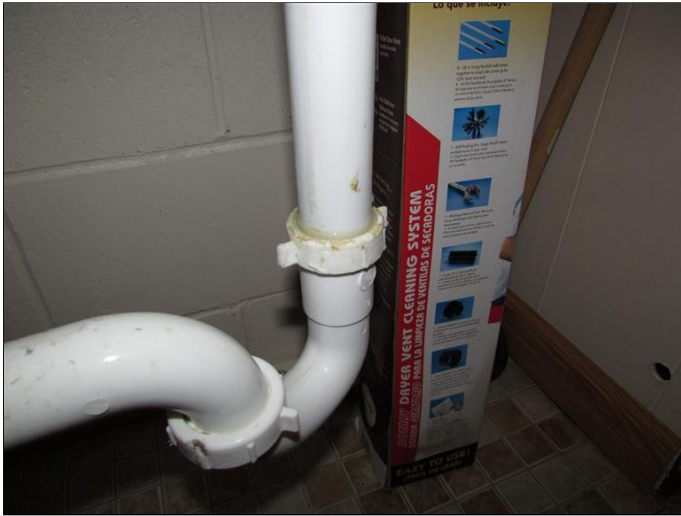
(2) There was a leak at the laundry sink drain that should be repaired.

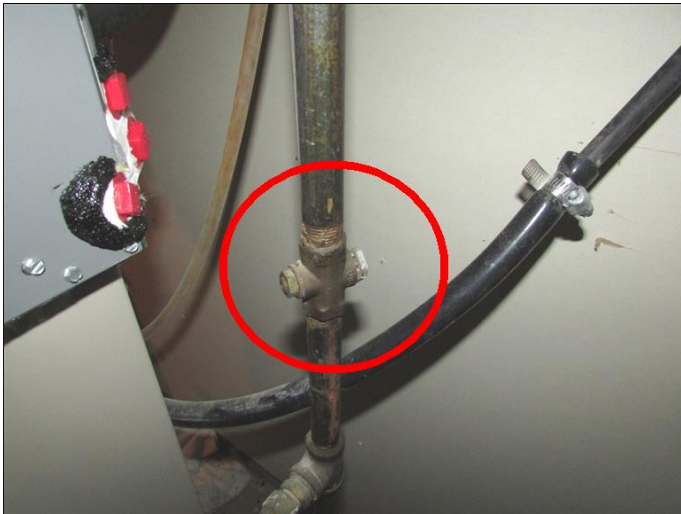
6.6 Fuel Lines

There was an old gas valve installed at the furnace, which tends to stick or leak with age. When this appliance is replaced, the gas valve should also be replaced.

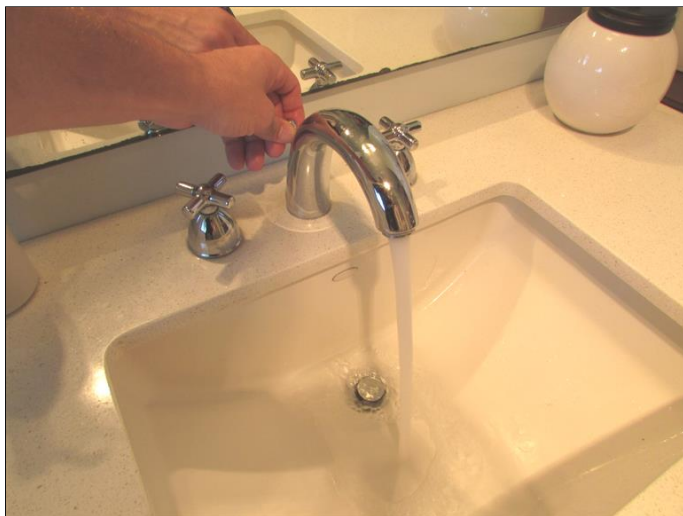
6.7 Bathroom Sinks

The mechanical sink stopper in the first floor bathroom did not function and will need to be serviced to work properly.

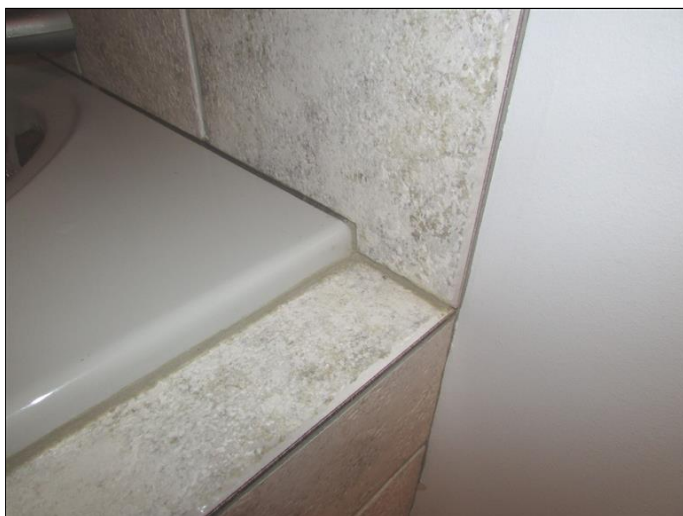
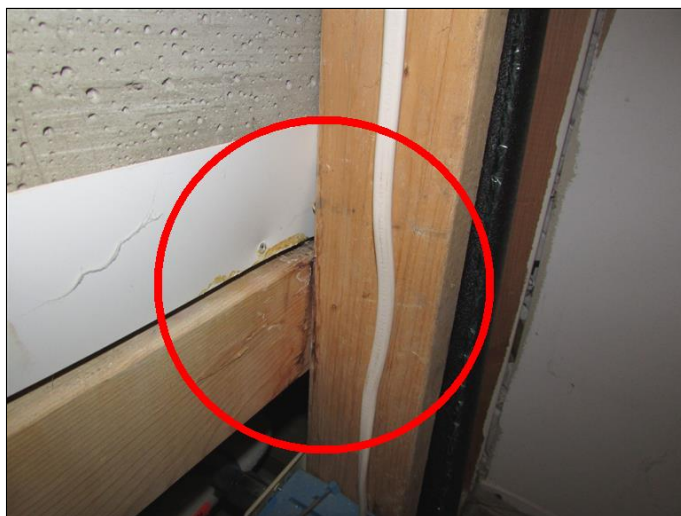
6.8 Bath Tub(s) / Shower(s)

The bath tub in the basement bathroom was a deck mount type of bath tub, but it was installed right up against the wall. This is an improper installation that will be prone to leakage at the wall. There is no practical repair for this, short of tearing out the tub and starting over. There were signs of historical leakage behind the tub, but the wood was dry at the time of the inspection. To help prevent future leakage at the tub / wall intersections, keep them well sealed with caulk.

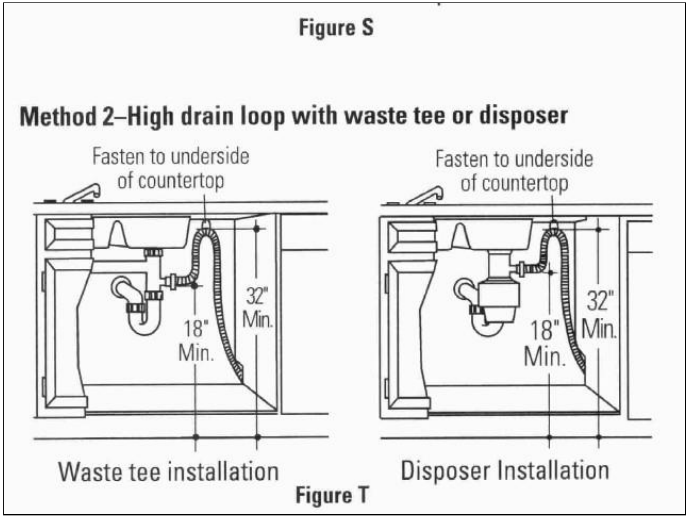
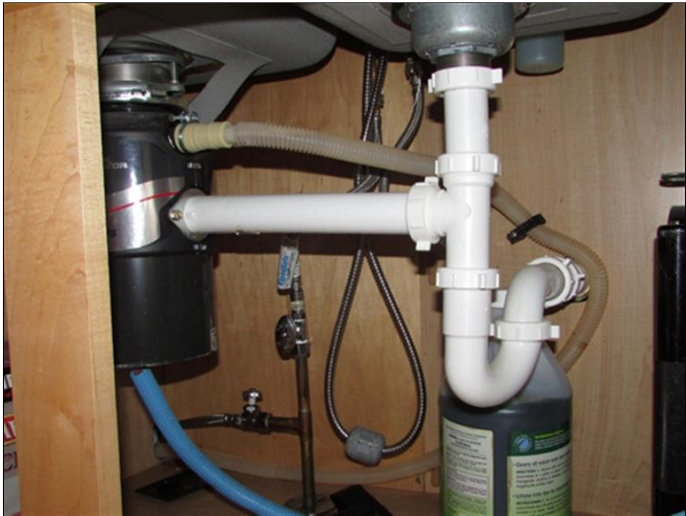
6.9 Kitchen Sink

The dishwasher drain did not have a proper high loop to prevent water from siphoning back into the dishwasher. This could lead to a cross-connection with the city water supply or a clogged dishwasher drain hose. Raise the dishwasher drain hose to match the diagram below. To read more about this specific issue, click here: [high loop at dishwasher drain](#).

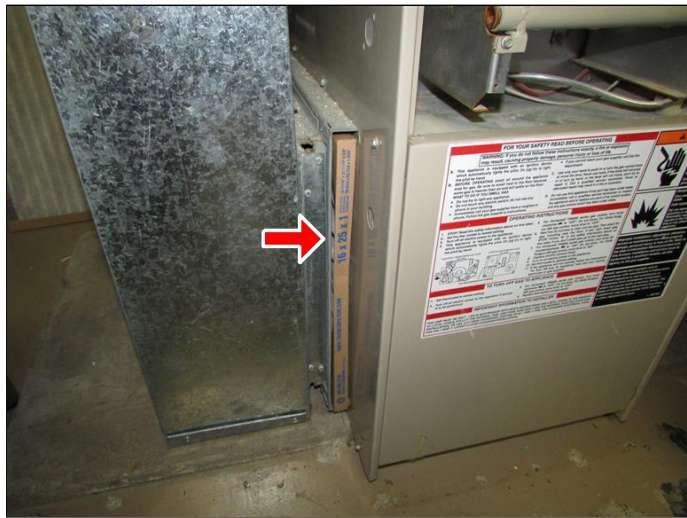
The cover was missing to the air filter. Install a tight cover to help prevent air in the basement from being pulled into the return air duct. This can cause excessive air pressure at the upper levels, which can lead to excessive air leakage from the house to the attic, which leads to frost in the attic and can contribute to ice dams.

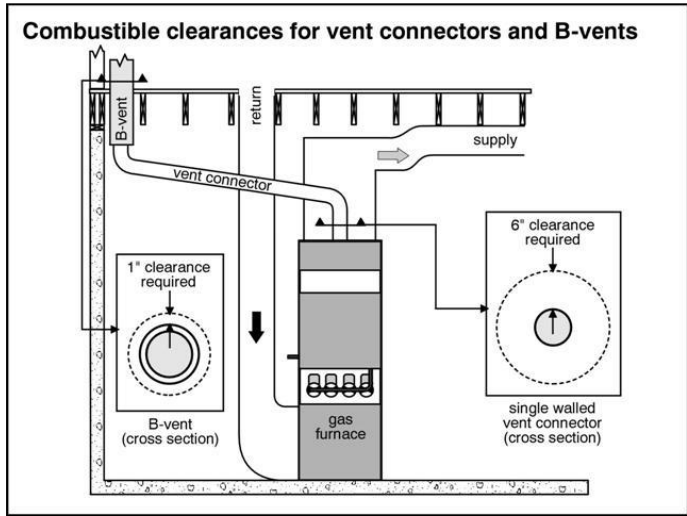
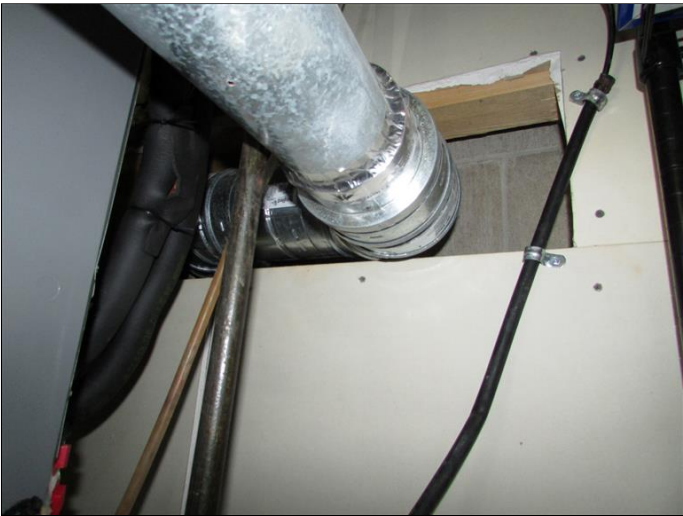
7.2 Vent Connector & Vent

The furnace vent connector lacks the required clearance to combustibles. The double-walled vent connector should be one inch away from the drywall and wood framing.

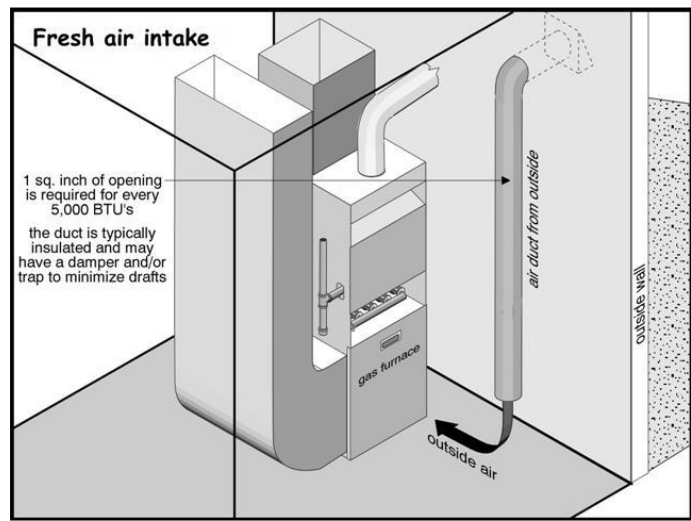
7.3 Combustion Air

There was no combustion-air duct in the furnace room. These are essential to support complete combustion, and without them carbon monoxide could be produced and pose a threat to the occupants. Have a combustion air duct installed. For more information on combustion air ducts, click here <http://www.structuretech1.com/blog/?p=67>

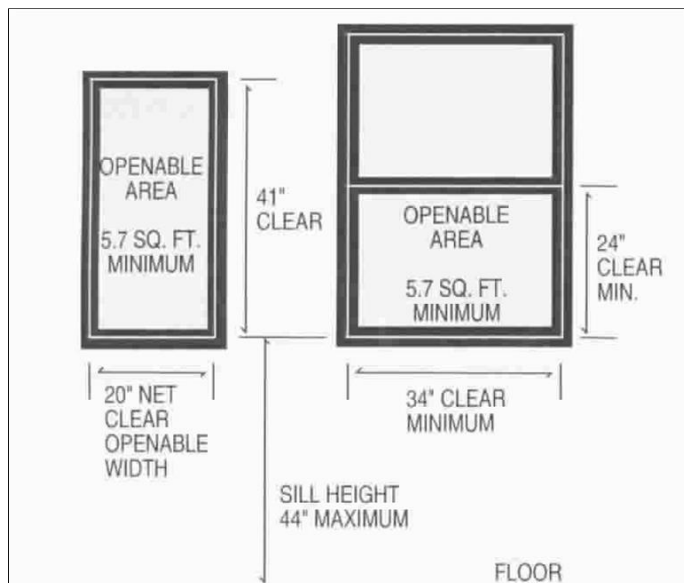
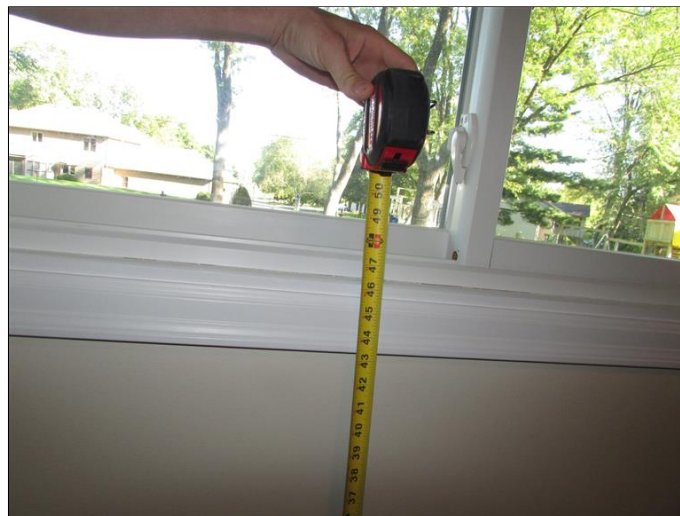
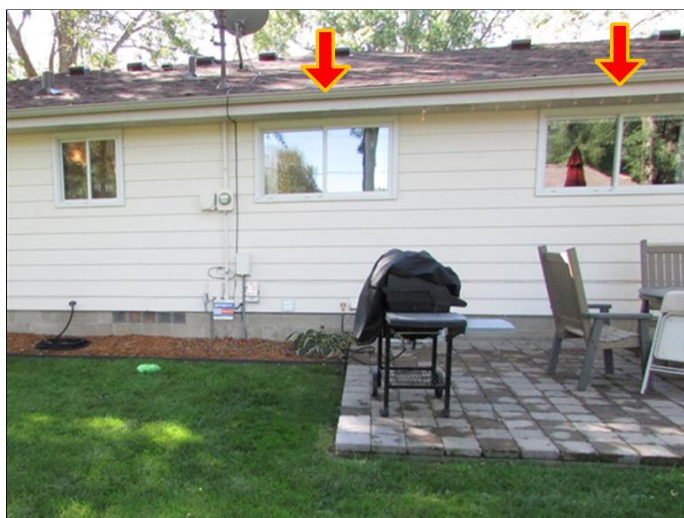
The center and west bedroom windows do not meet today's egress requirements for *new* windows. The current size requirement for an egress window is that it opens at least 24" high, 20" wide, and has a net clear opening of at least 5.7 square feet. Additionally, the bottom of the window can not be more that 44" from the ground and can not require special tools or knowledge to open. This is not a major concern, as the windows had large enough openings for most people to climb through in the event of an emergency.

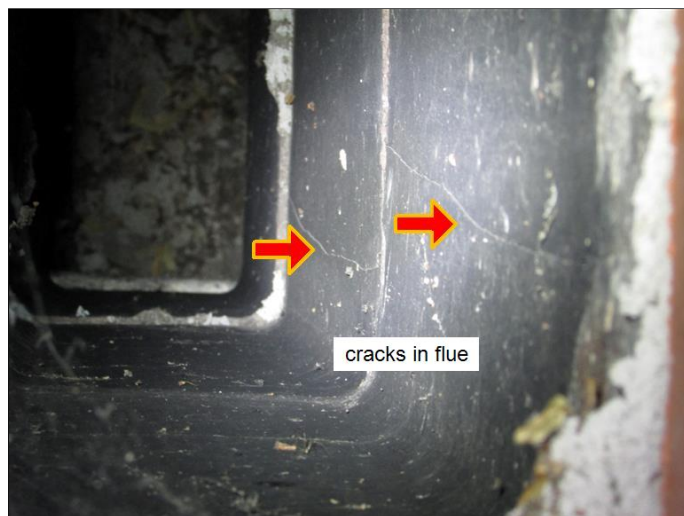
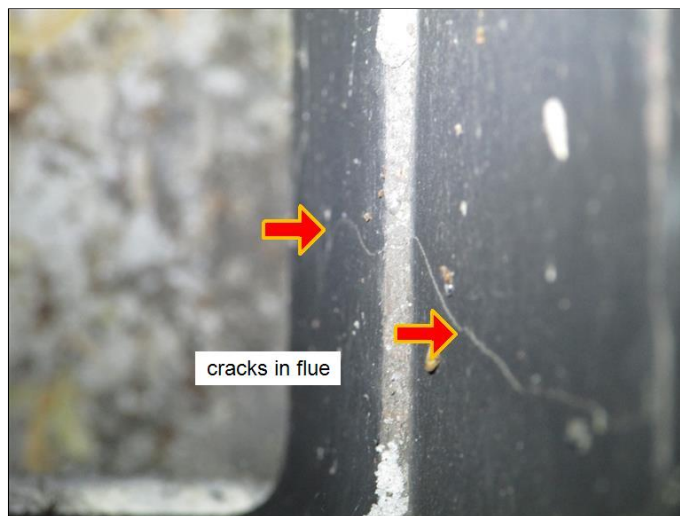
(2) The wood burning fireplace had a gap between the smoke shelf and the first section of clay liner. This area must be tightly sealed to help prevent the passage of heat and smoke into the wood framed wall, which could start a fire.

There were also cracks in the flue liner that should be repaired before the fireplace is used. The smallest cracks can expand under thermal pressure to create a fire hazard.

Have the wood burning fireplace repaired by a [CSIA Certified Chimney Sweep](#) before using it.

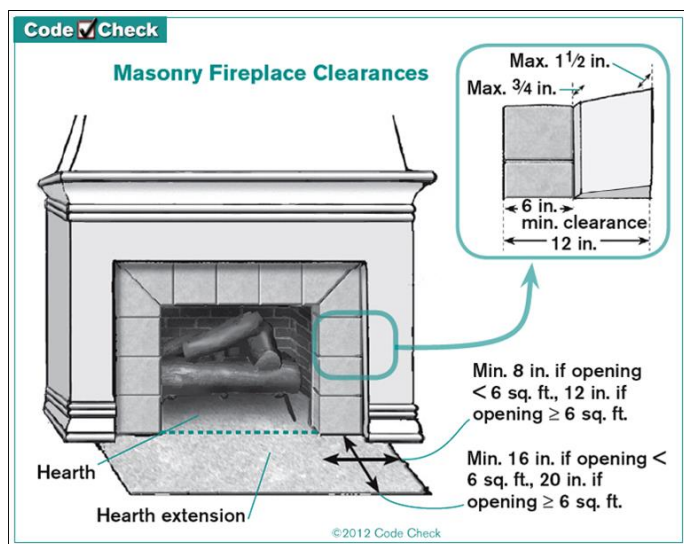
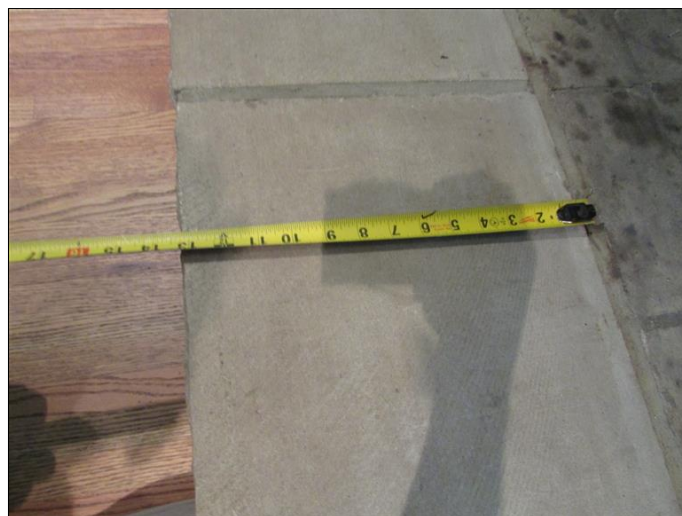
(3) The wood burning fireplace hearth extension did not have standard dimensions, which would require it to extend at least twenty inches from the front of the opening, and eight inches on either side, as the fireplace opening was over 6 sf. This is needed to help prevent a spark from landing on the floor and starting a fire. Have this corrected before using the fireplace.

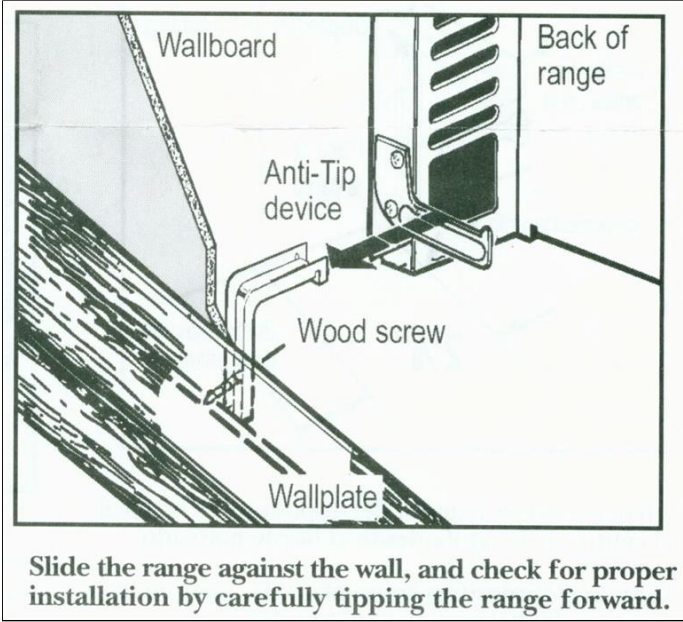
The range was missing an [anti-tip device](#), which is needed to help prevent the range from accidentally tipping over. This is an important safety device that should be installed.

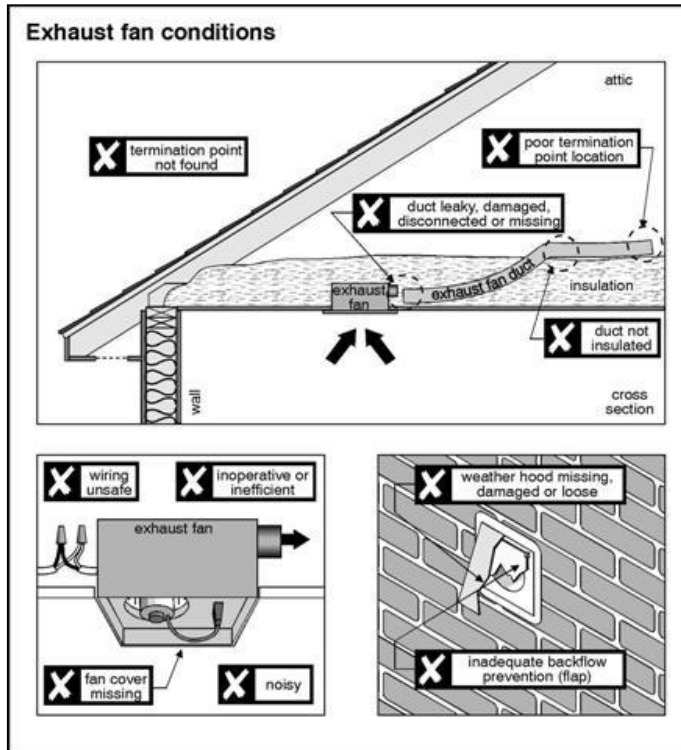
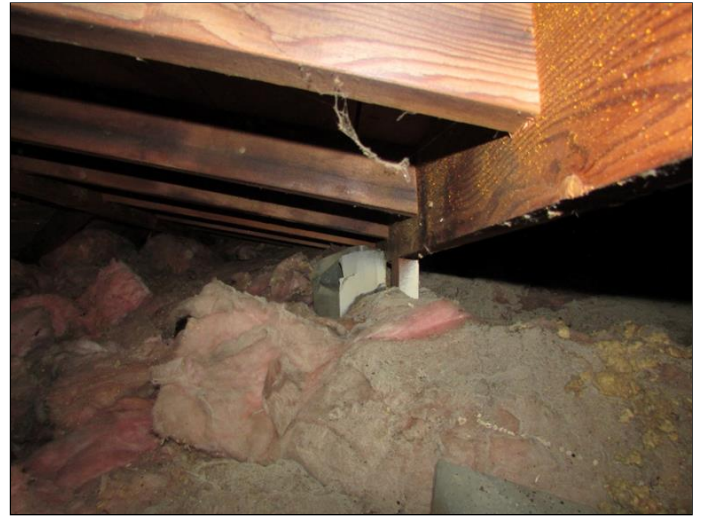
(1) The kitchen exhaust fan was vented into the attic, which causes all of the warm, moist air to discharge into the attic space, rather than to the exterior. This can cause a long list of problems with the attic, including rotted roof sheathing, frost in the attic, grease in the attic, and ice dams. The kitchen exhaust fan needs to have ductwork installed that is airtight, insulated, and continuous to the exterior. Have this corrected.

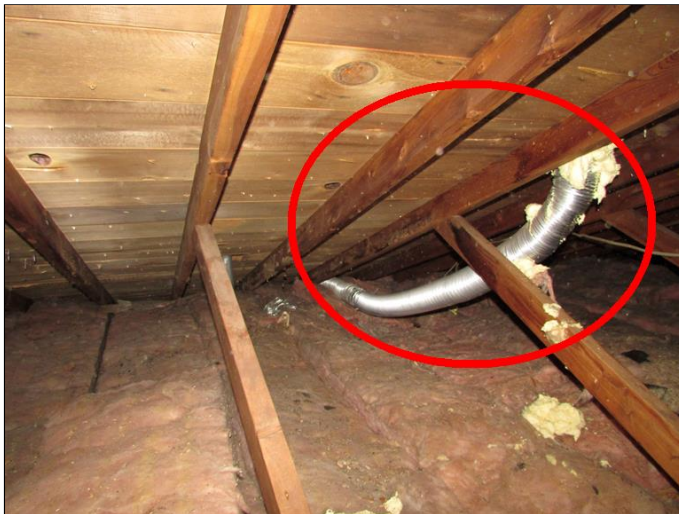
(2) There was no insulation on the bath fan exhaust duct. Replace the duct with an insulated duct to reduce heat loss and potential ceiling damage from condensation.
