Structure Tech Home Inspections

Inspection Report

Property Address:
12345 Super Happy Street
Minneapolis MN

Date: 9/21/2015	Time: 09:00 AM	Report ID:
Property: 12345 Super Happy Street Minneapolis MN	Customer: New Buyer	Real Estate Professional:

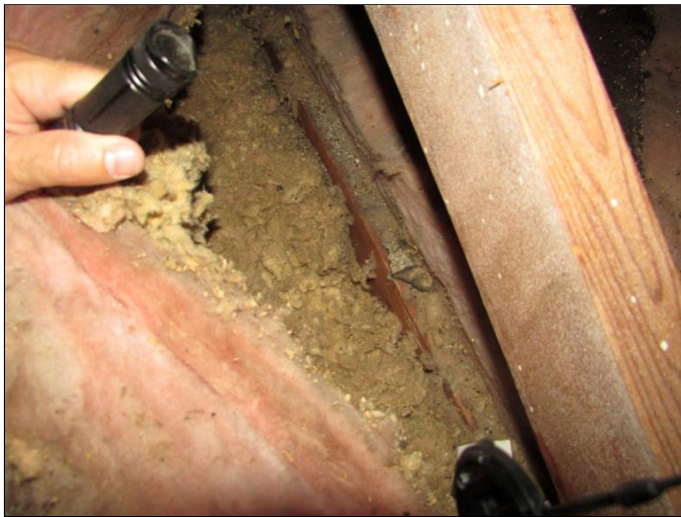
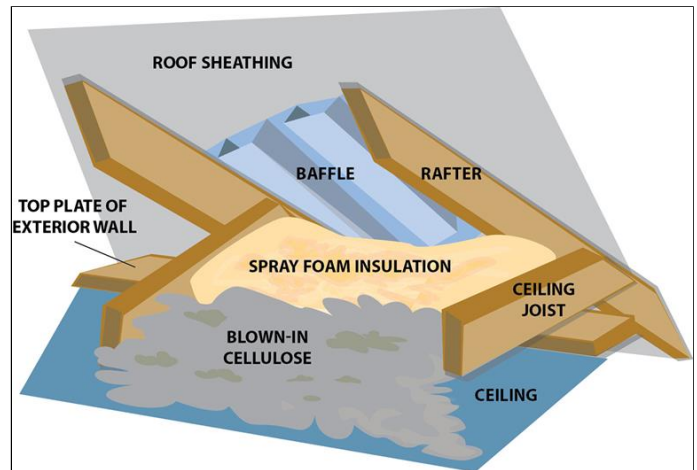
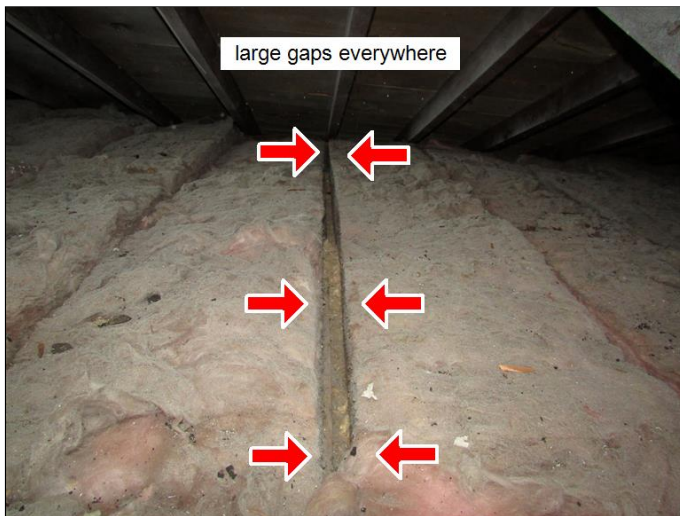
10.1 Attic Insulation

(1) Attic insulation consists of fiberglass batts installed on top of a few inches of loose fiberglass. The batts have been somewhat haphazardly installed, leaving large gaps in the insulation all over the attic. These gaps equate to an exponential level of heat loss through the attic space. Because of how difficult it is to properly install fiberglass batts, I recommend removing the batts and having the attic re-insulated with loose-fill insulation. This will help to reduce energy loss and lower the potential for ice dams. For information about the importance of evenly distributed insulation in the attic with no gaps, click [here](#).

Insulation at the eaves was minimal, which will allow for significant heat loss at the top wall plates. To reduce the heat loss here, you would need to have a different type of insulation installed at this location, such as closed cell foam. You can read more about this by clicking here: [Insufficient Insulation at Eaves](#).

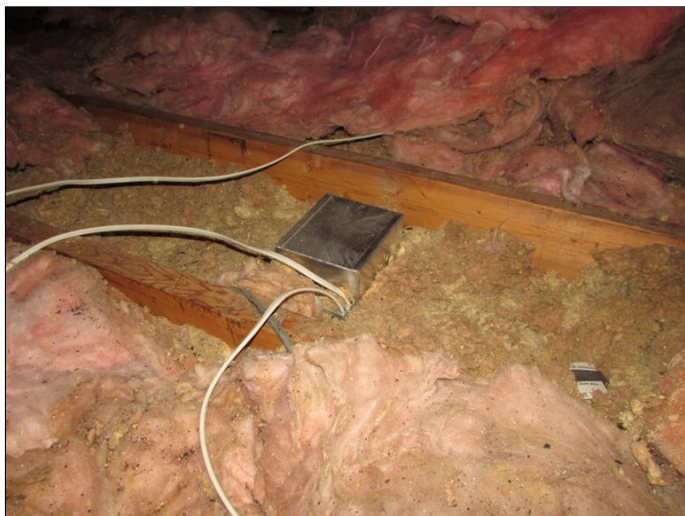
(2) There were [inadequately insulated recessed lights](#) in the attic. Install insulated boxes over the recessed lights to prevent heat from entering the attic and increasing the potential for ice dams.

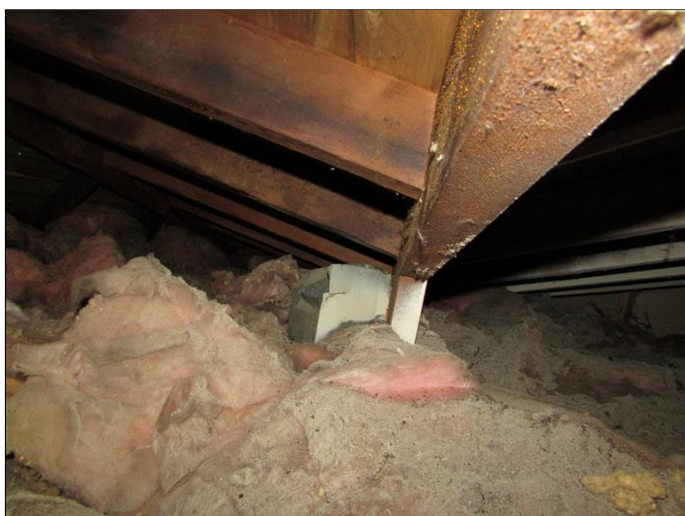
There were attic air leaks that should be sealed to help prevent conditioned household air from entering the attic space. Attic air leaks allow moisture into the attic which shows up as [frost](#), can reduce the effectiveness of insulation by as much as 70%, and are a major contributor to ice dams. Have the attic bypasses sealed by a qualified insulation contractor. For information about where to find these attic air leaks and how to correct them, download this [Guide to Attic Air Sealing](#).

kitchen hood terminates in attic

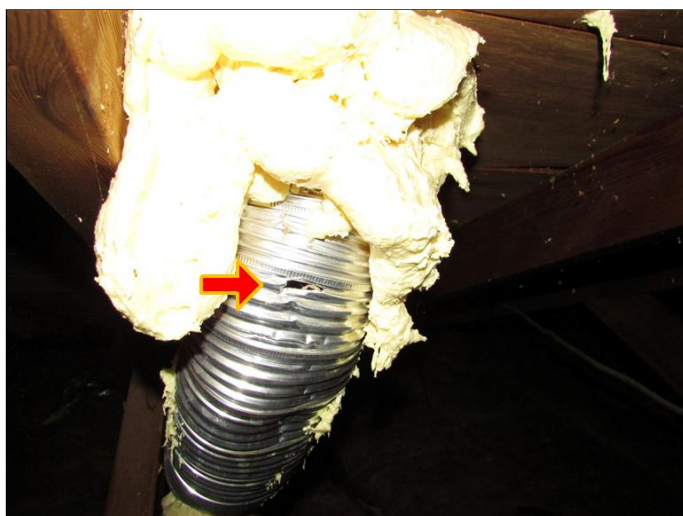
hole in bath fan duct

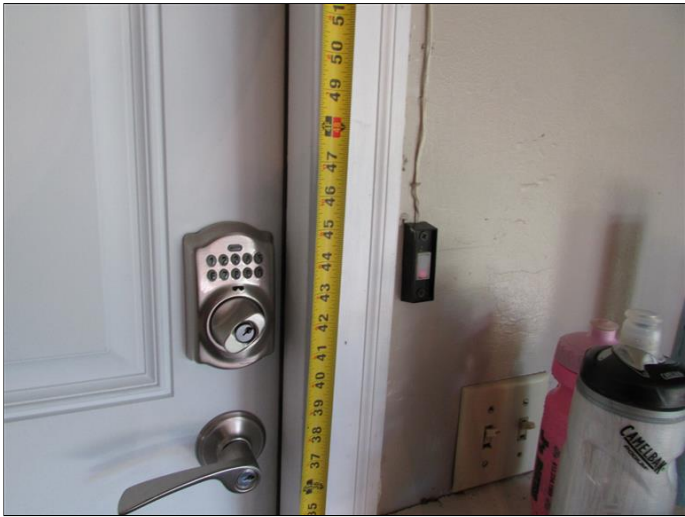
The wall button for the garage door opener was less than five feet high, which is the minimum required height to help prevent small children from operating the opener. Raise the opener button for safety.

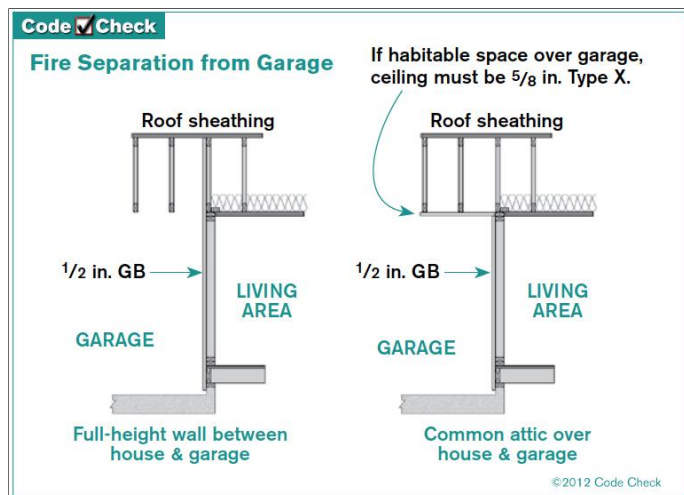
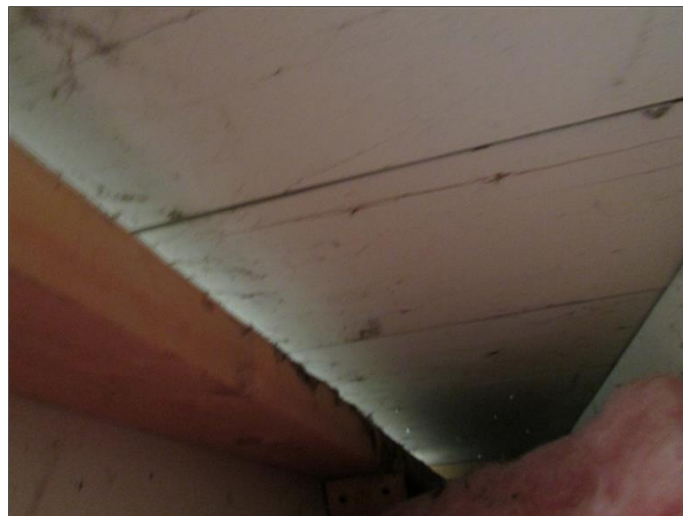
11.2 Fire Separation

There were voids in the garage / house wall, extending the entire width of the house, that should be repaired, in order to maintain the necessary fire separation between the garage and the living quarters.

The wooden hatch cover to the attic area should be sheathed with metal or drywall in order to maintain the proper fire separation between the garage and the living quarters. This is to slow the potential spread of a fire. Have this fixed.

drywall stops short of roof sheathing

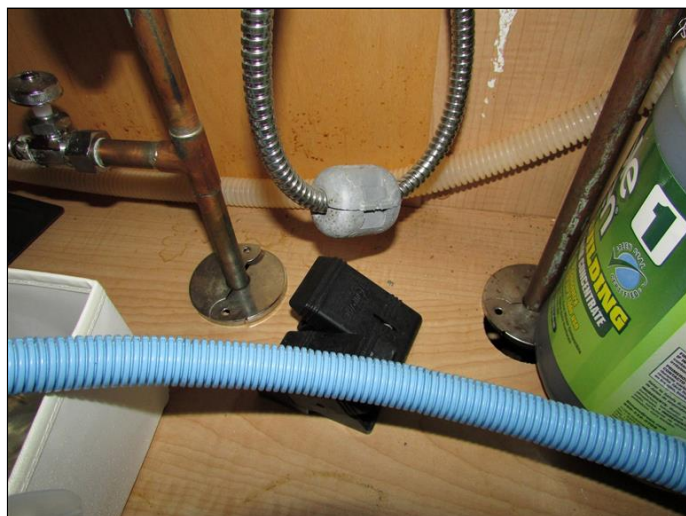
There were mouse traps present under the kitchen sink. These usually indicate rodent problems.
