## Structure Tech Home Inspections

# Inspection Report

**Property Address:**  
12345 Happy Lane  
Minneapolis MN

<b>Date:</b> 8/15/2017	<b>Time:</b> 08:30 AM	<b>Report ID:</b>
<b>Property:</b> 12345 Happy Lane Minneapolis MN	<b>Customer:</b> Experienced Home Buyer	<b>Real Estate Professional:</b>

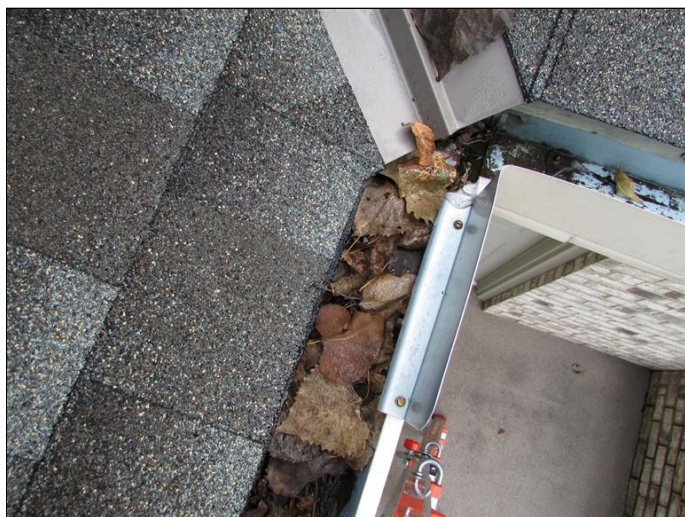
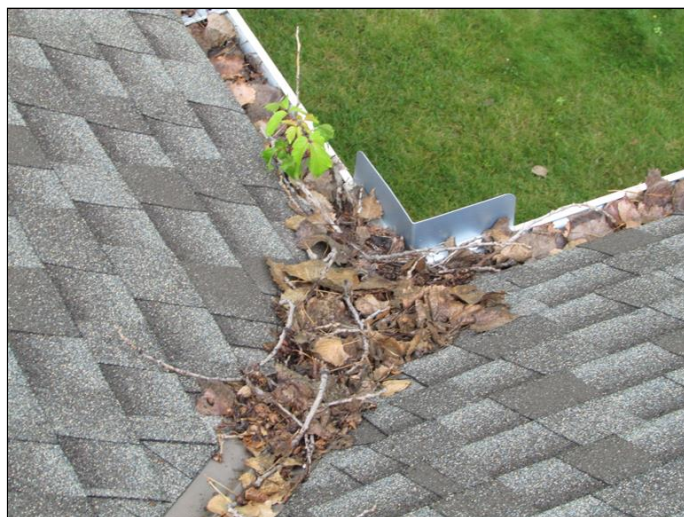
The gutters contained debris that will prevent them from draining properly. Clean the gutters.

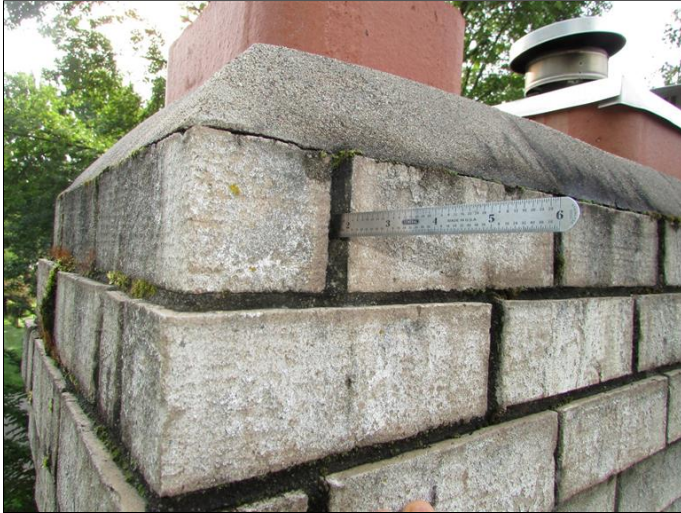
There were cracks in the chimney walls that will allow water into the chimney, leading to deterioration and possibly interior leaks. Have the chimney serviced / repaired by a [CSIA Certified Chimney Sweep](#).

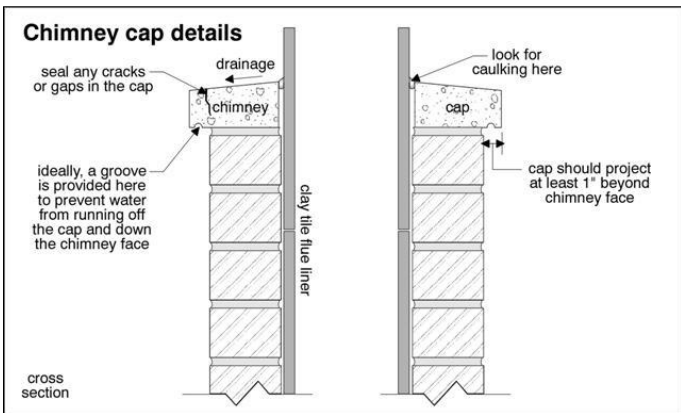
### 2.1 Chimney Crown

The chimney crown was cracked. These cracks will allow water into the chimney and should be sealed to help prevent damage to the chimney.

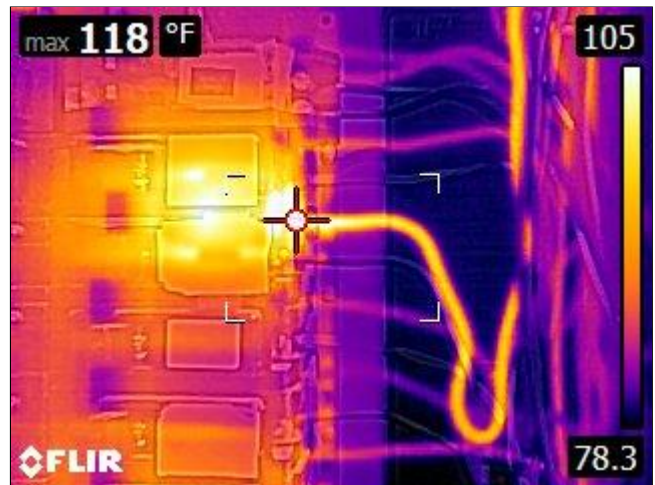
- ✘ (3) The circuit breaker at space #18, labeled "upstairs bathroom", supplied power to the upper hallway bathroom, the master bathroom, upper hallway lights, upper den (piano room) lights and outlets, and most of the recessed lights at the west basement family room. This circuit is overloaded, and it tripped several times during the inspection. Have an electrician correct the wiring. Because the main panel was filled to capacity, the fix for this condition might require the installation of a subpanel.

- (3) The circuit breaker at space #18, labeled "upstairs bathroom", supplied power to the upper hallway bathroom, the master bathroom, upper hallway lights, upper den (piano room) lights and outlets, and most of the recessed lights at the west basement family room. This circuit is overloaded, and it tripped several times during the inspection. Have an electrician correct the wiring. Because the main panel was filled to capacity, the fix for this condition might require the installation of a subpanel.

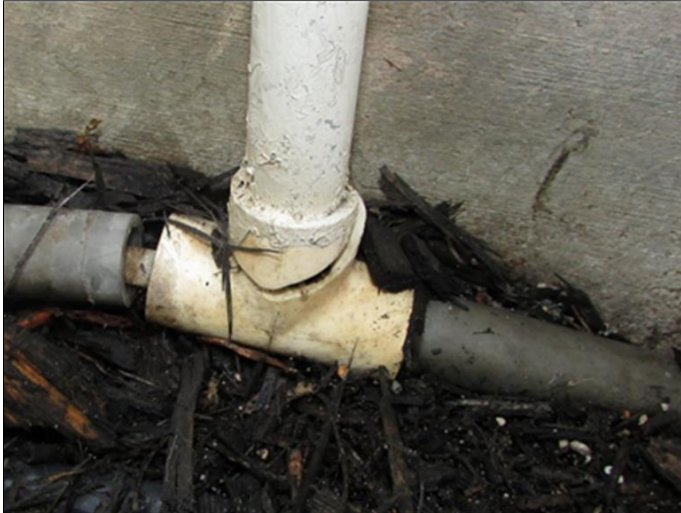
- (2) There was broken and disconnected conduit for the front yard outlets. This may allow for the wire to be damaged. Have the conduit repaired.

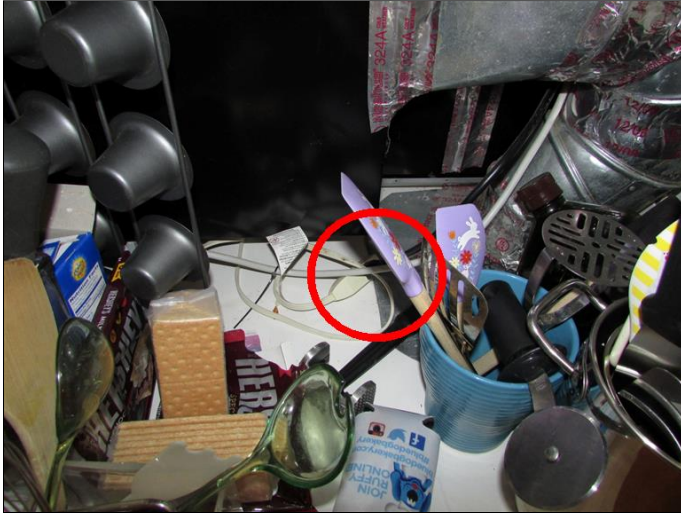
- (2) The downdraft fan was plugged into an extension cord, but should be plugged directly into its own outlet for safety. Have an outlet installed if needed.

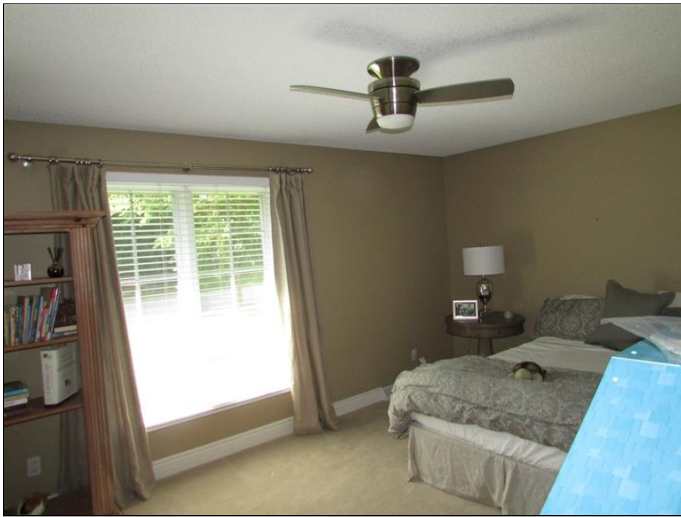
(6) The ceiling fan in the SW bedroom was not functional, nor was the light.

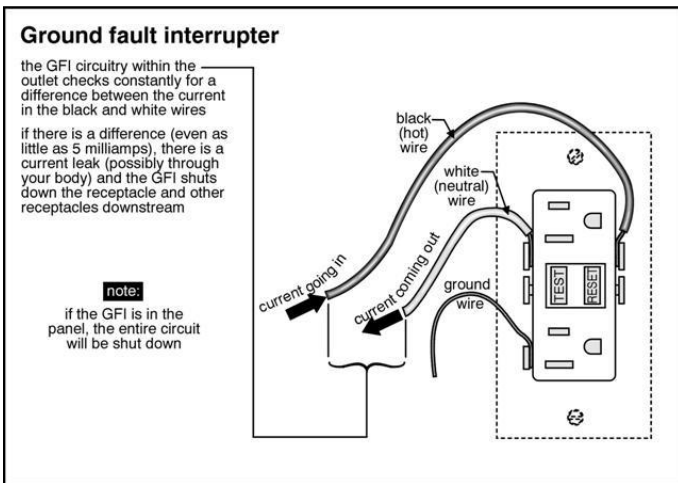
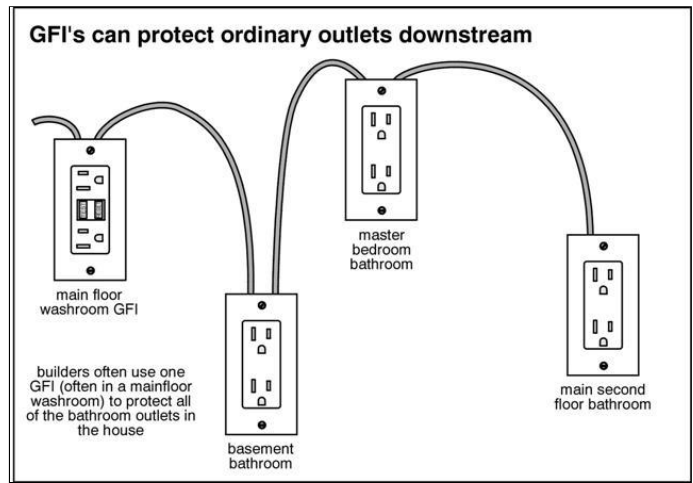
(1) The unfinished basement, laundry room, garage, and some of the exterior and kitchen outlets were not GFCI protected. The basement bathroom outlet was also not GFCI protected. Add [GFCI](#) protection for these outlets to lower the risk of a lethal shock.

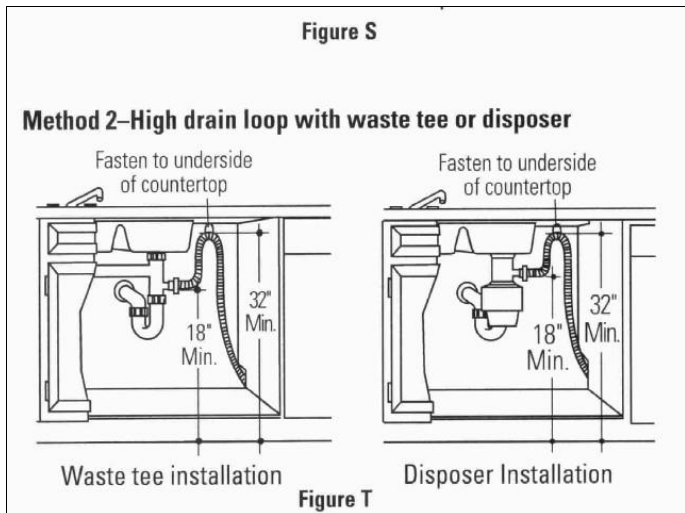
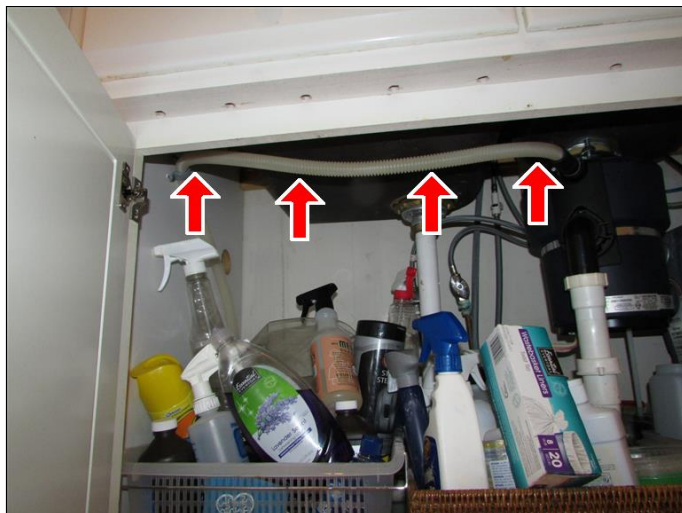
The dishwasher drain did not have a proper high loop to prevent water from siphoning back into the dishwasher. This could lead to a cross-connection with the city water supply or a clogged dishwasher drain hose. Raise the dishwasher drain hose to match the diagram below. To read more about this specific issue, click here: [high loop at dishwasher drain](#).

Note: the new Minnesota State Plumbing Code now requires an air gap on new dishwasher installations: <http://structuretech1.com/2016/03/new-minnesota-plumbing-code/#dwairgap>

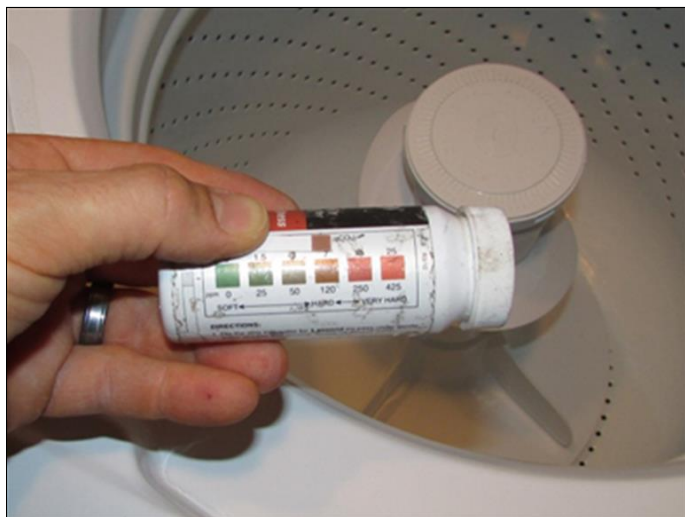
**6.8 Water Softener**

The photo below shows a hardness test strip, taken from cold water at the laundry sink. This equates to approximately 7 grains of hardness, which is marginal.

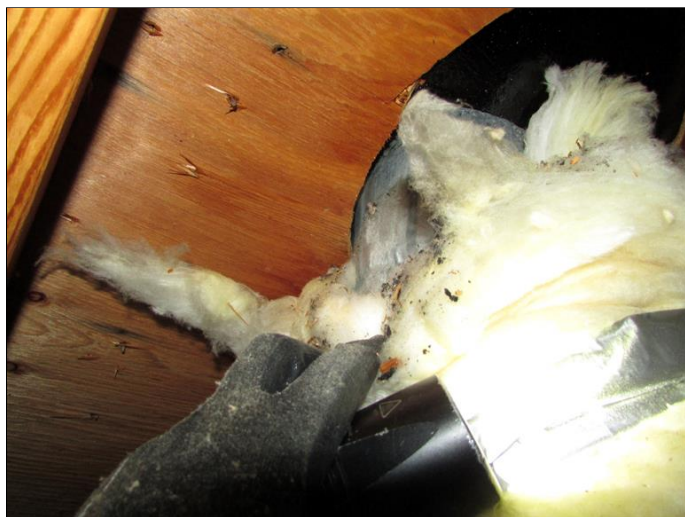
- The furnace vent was touching the roof sheathing, but should be at least 1" away to lower the potential for a fire. This isn't a major concern.

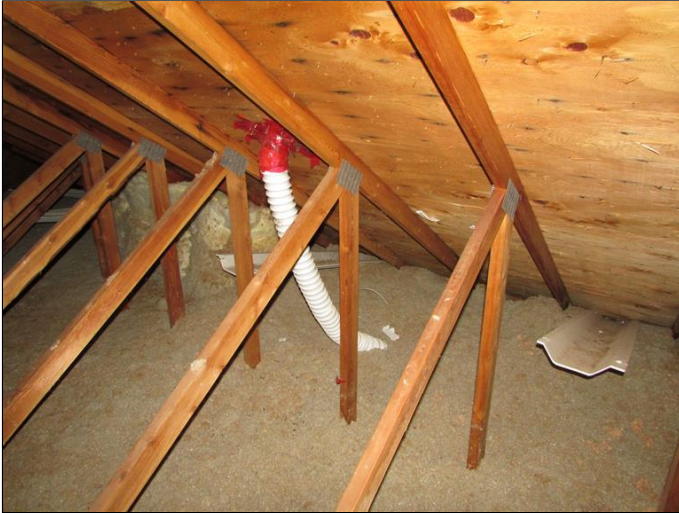
There was no insulation on the master bath fan exhaust duct. Replace the duct with an insulated duct to reduce heat loss and potential ceiling damage from condensation.

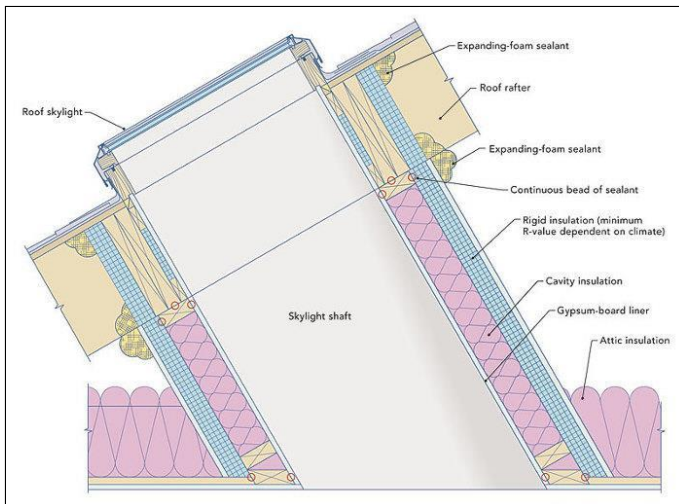
There were signs of past staining and condensation around both skylights.

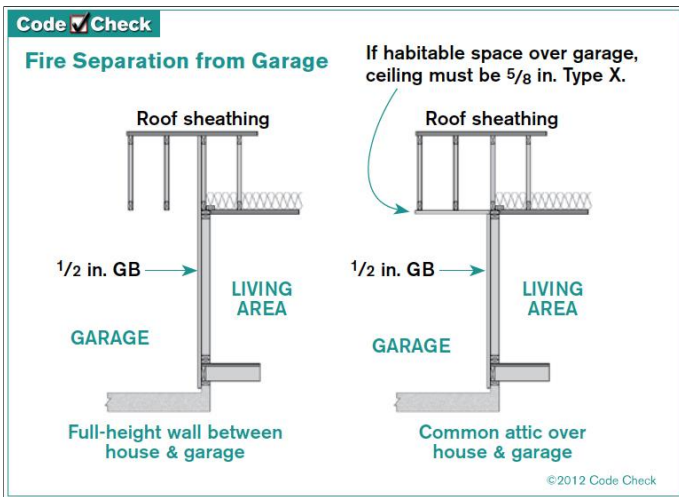
**🔄** There were voids in the garage / house wall that should be repaired, in order to maintain the necessary fire separation between the garage and the living quarters.

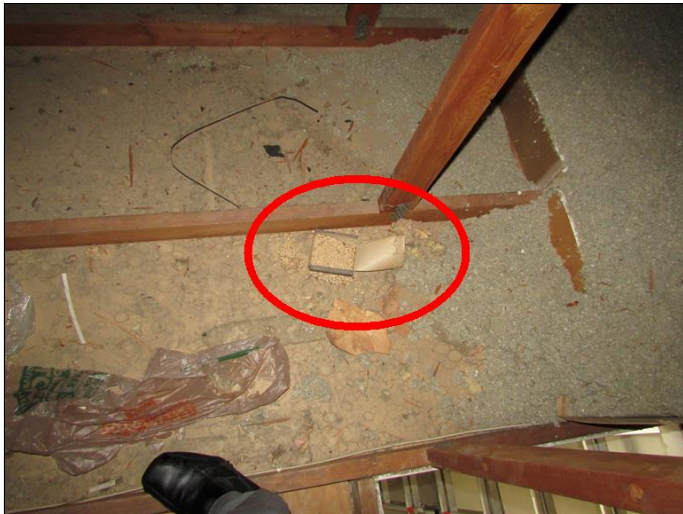
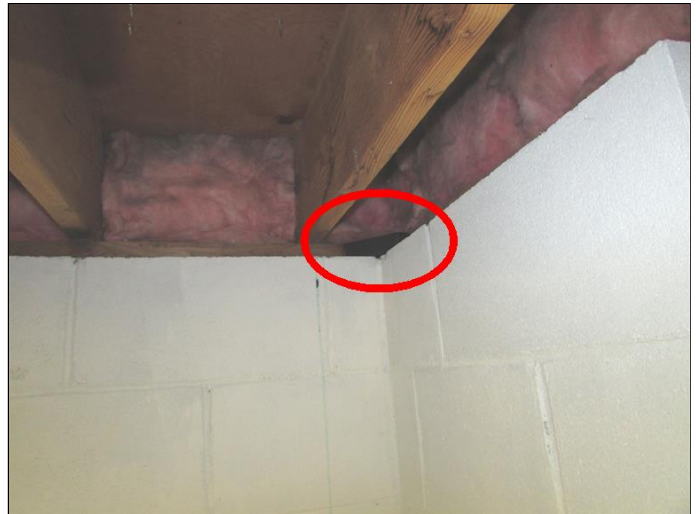
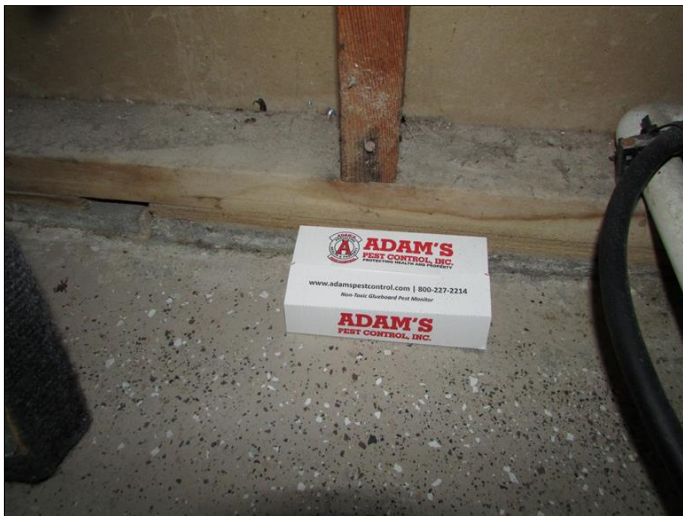
- There were mouse bait stations or traps present in the attic and basement.
