Structure Tech Home Inspections

Inspection Report

Property Address:
12345 Super Happy Street
Minneapolis MN

Date: 9/21/2015	Time: 09:00 AM	Report ID:
Property: 12345 Super Happy Street Minneapolis MN	Customer: New Buyer	Real Estate Professional:

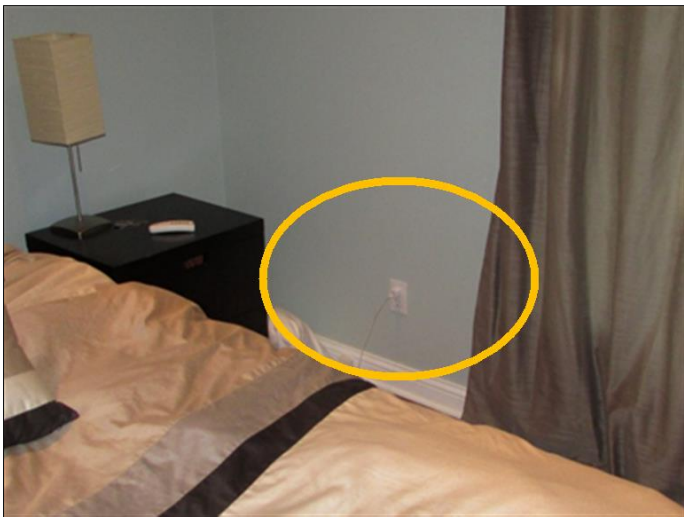
east wall, NE bedroom

- (1) There were several [ungrounded three prong outlets](#) present, indicated in the photos below. These are potential shock hazards, and can allow equipment that is plugged into these outlets to be damaged. Have the wiring corrected.
- (2) There was [reversed polarity](#) to the north wall outlet in the northwest bedroom. This means that the hot and neutral wires have been wired backwards at some point in between or at the main service panel and the outlet. This is a shock hazard. Have the wiring repaired.

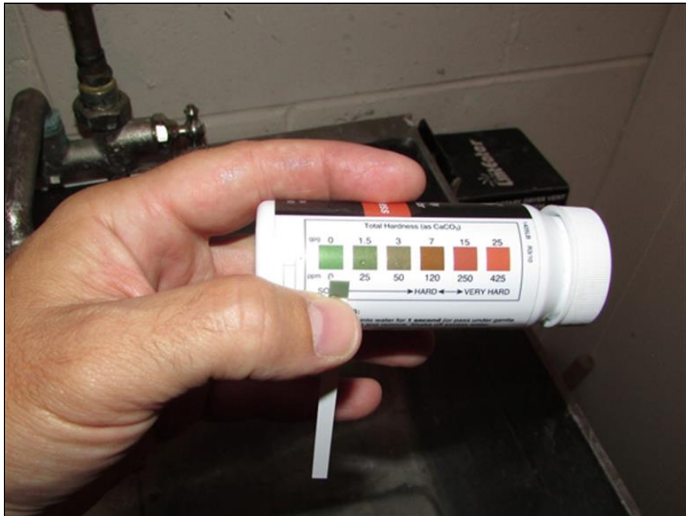
The photo below shows a hardness test strip, taken from cold water at the laundry sink.

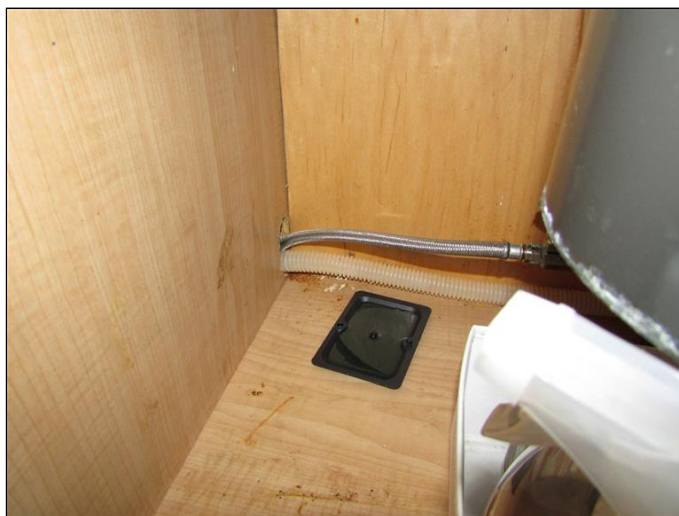
There were mouse traps present under the kitchen sink. These usually indicate rodent problems.
